Failure Analysis of Turbine Engine Compressor Front Hub/Disk

**Luis R. Carney, P.E.
Materials Engineer
Jacksonville, Fl.**

AEROMET CONFERENCE

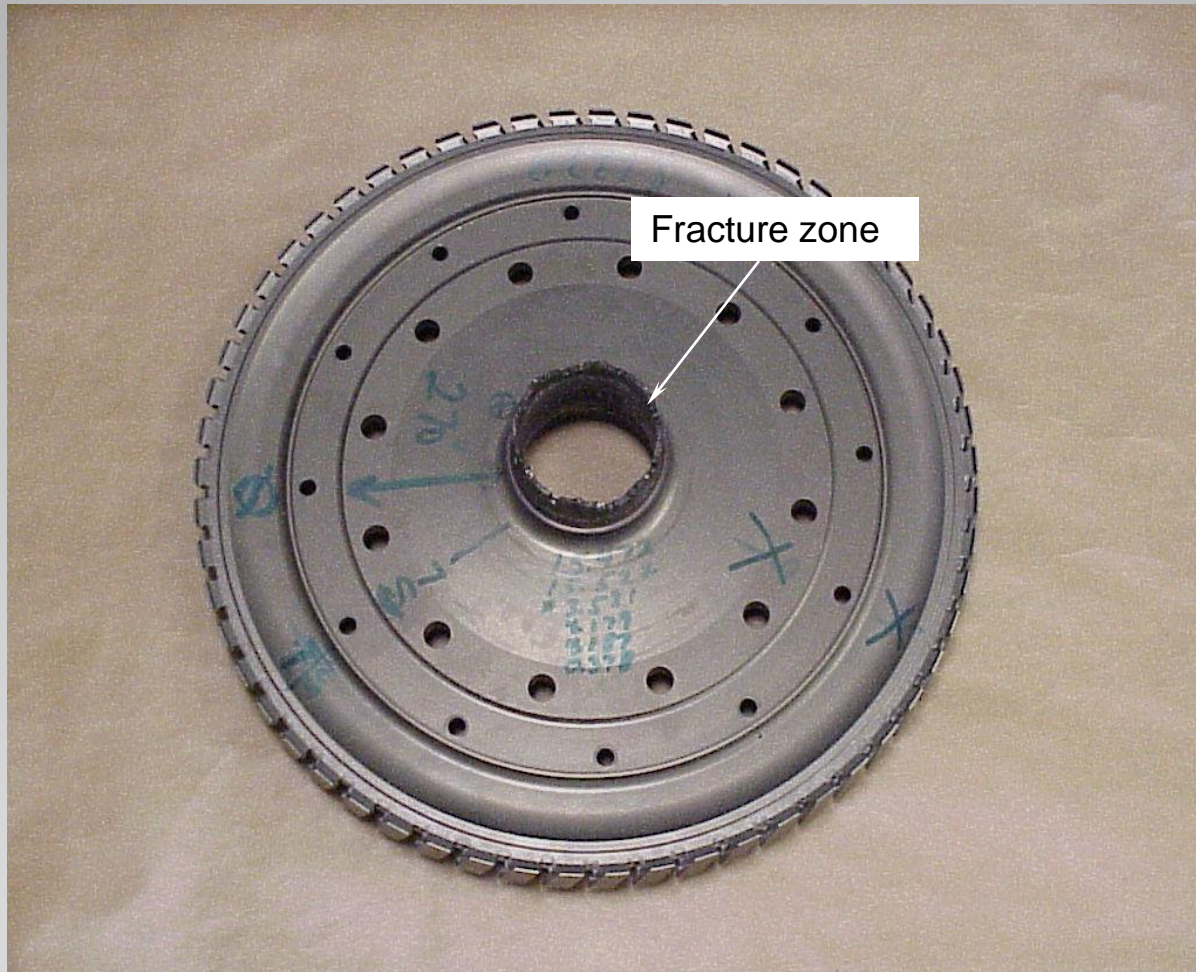
N2 Front Hub/Disk as received

- Engine being test run after overhaul
- Time Since Overhaul: 0 hours
- Time on Hub: Apx 1,893 hours.
- Test run revealed high breather pressure & oil out of bleed valves
- Disassembly revealed fractured N2 hub

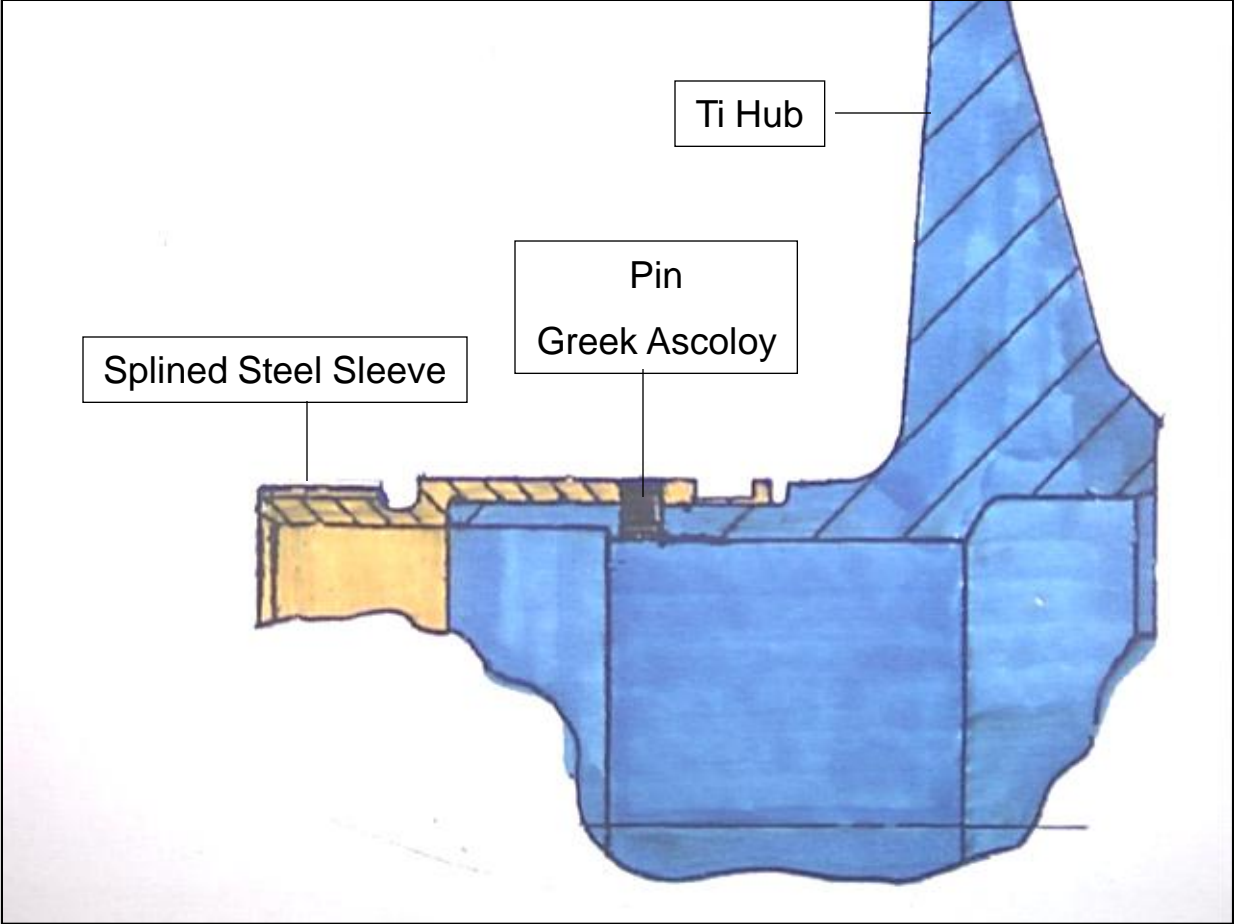
Drawing of Ti Hub to Steel Sleeve modification

- Hub repair instituted in 1968 to resolve premature wear problem.
- All N2 Hubs modified this way.
- Sleeve pressed in and secured with 8 pins.
- Fracture plane was along pinned Hub plane.

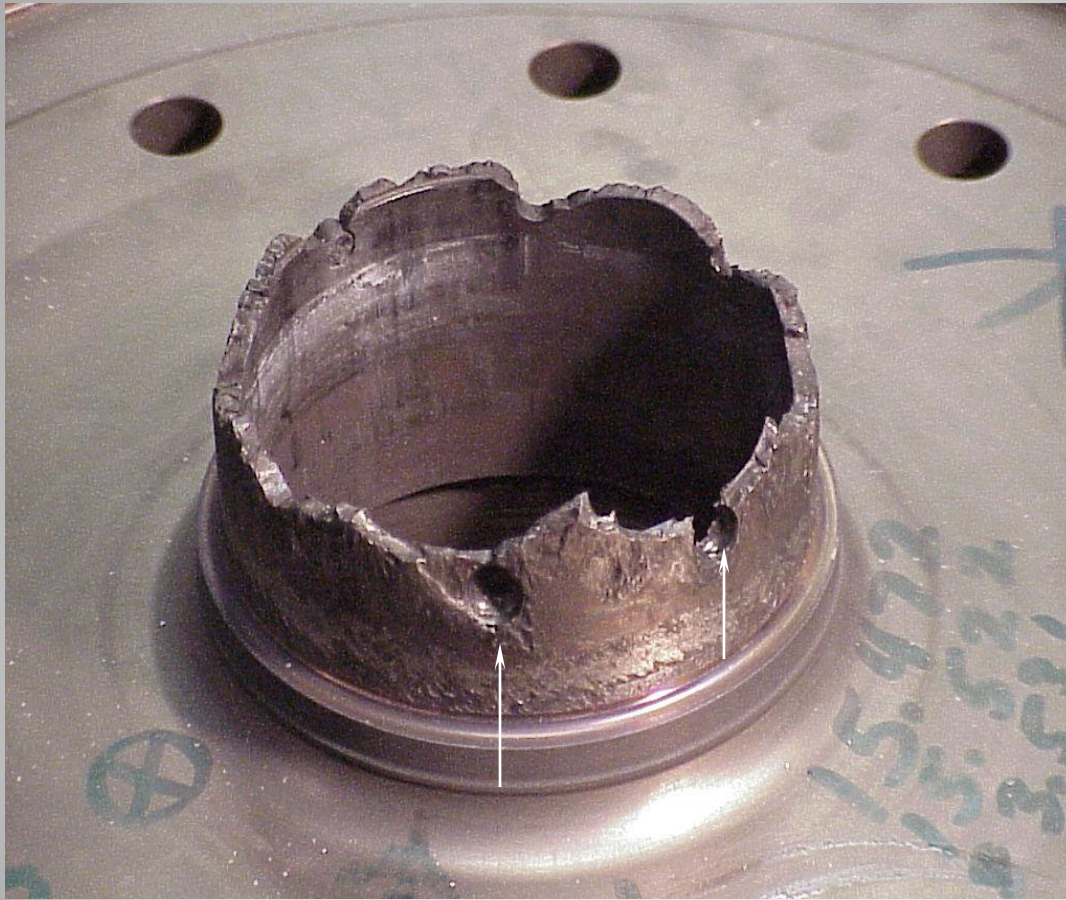
- Hub OD severely galled.
- Pin bores elongated and deformed.
- 3 of 8 pins severely deformed.
- 5 pins remained in their bores.

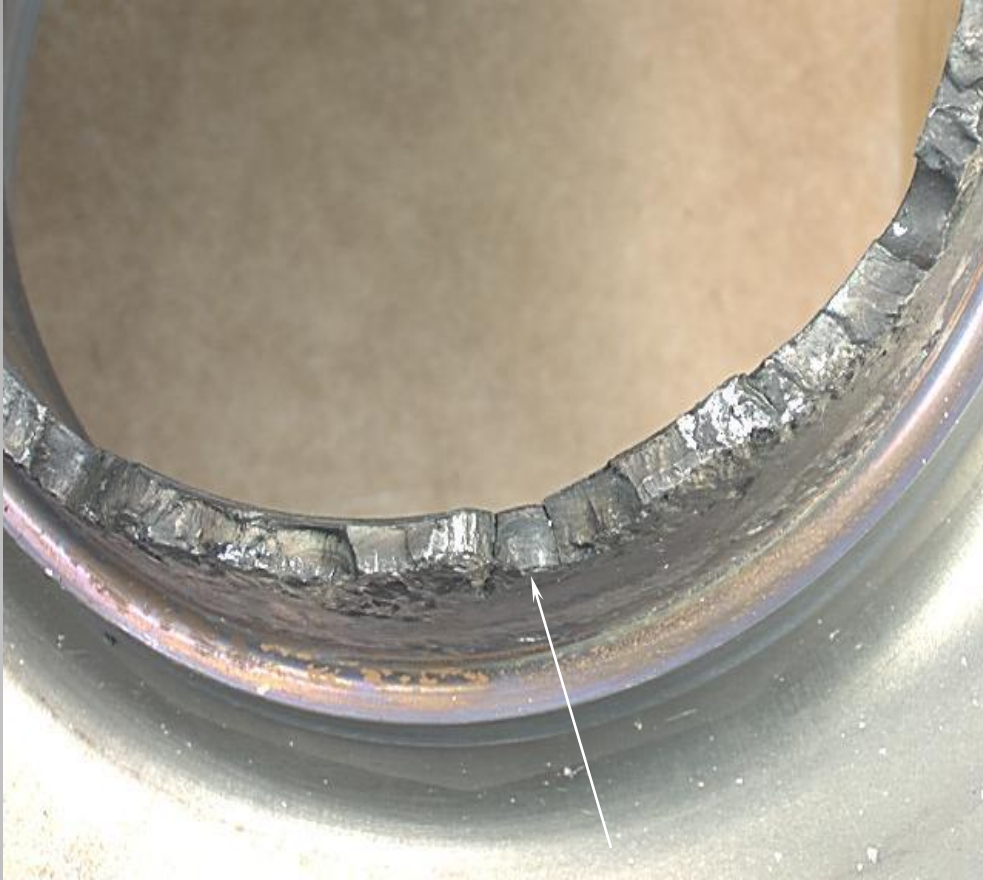
- Five of the pins had been fractured through the interface between sleeve ID and Hub OD

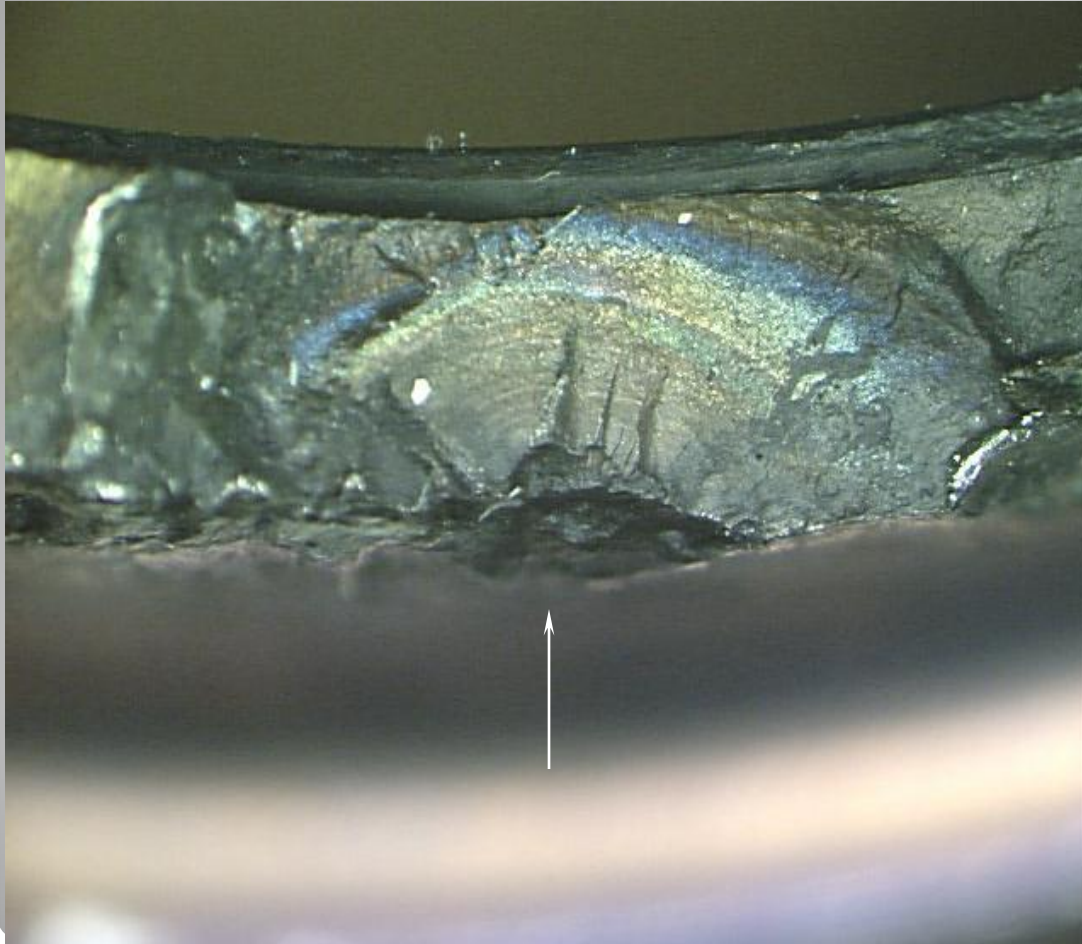
- One of many thumbnail shaped cracks that formed part of the larger fracture surface.
- Origin at a severe galling pit.
- Cracks progressed from OD to ID.

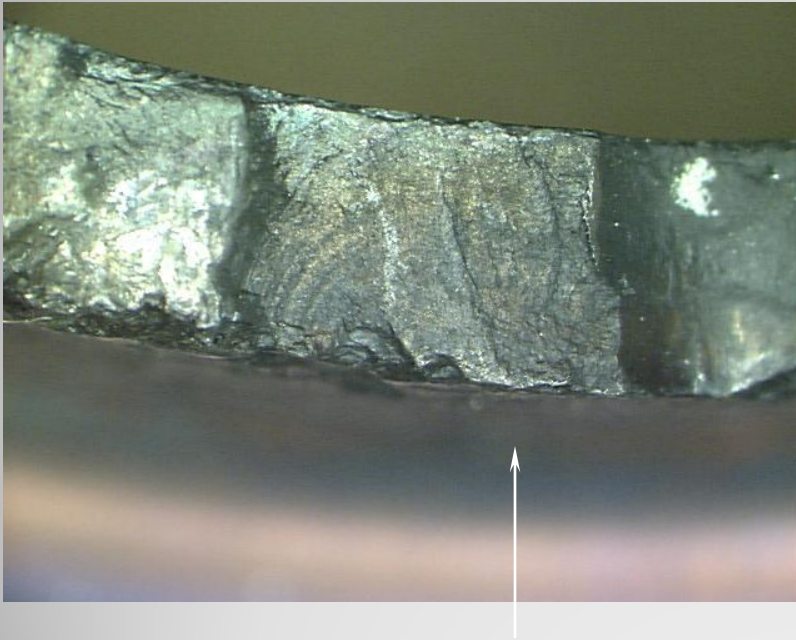
- Another hub crack. Note that origin (Arrow) is at Hub OD not pin bore.
- Bores containing fractured pins were in "good" condition

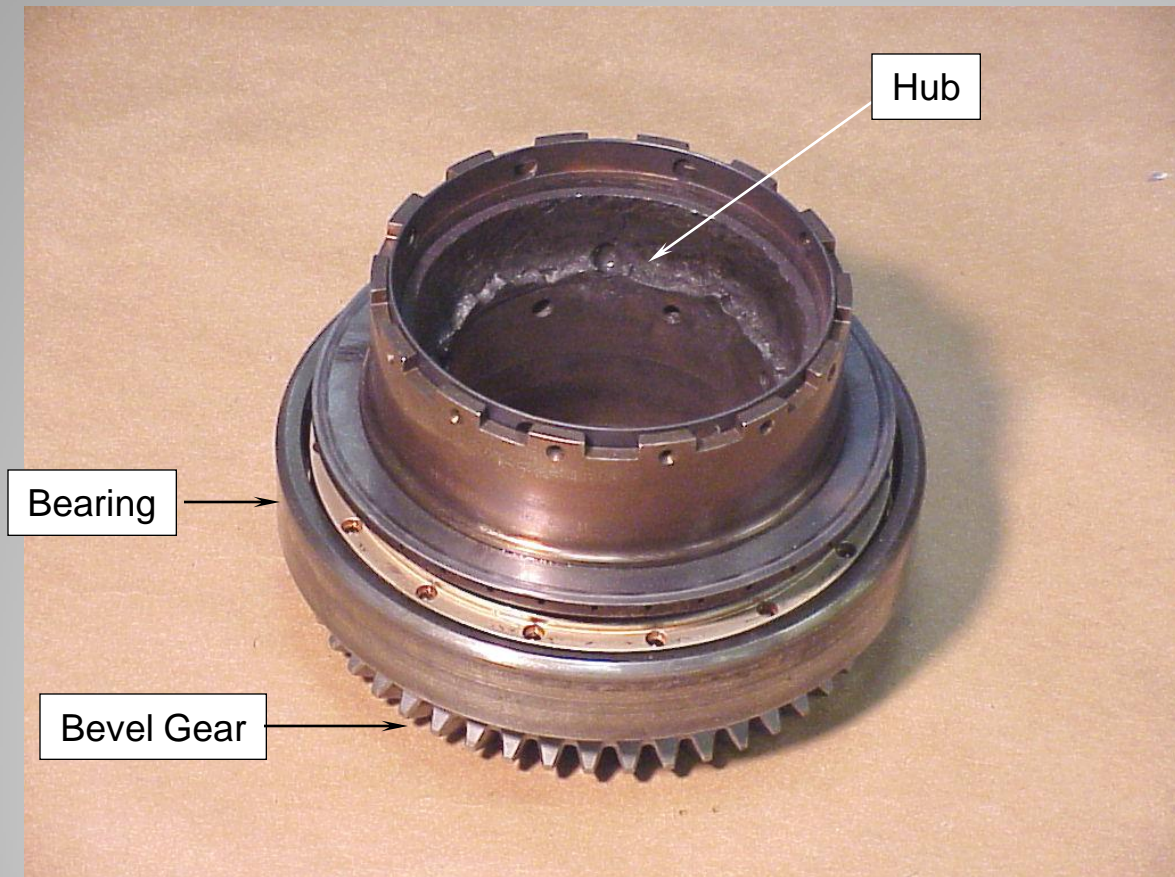
N2 front bearing assembly
Part of the N2 hub and steel splined end are still inside the assembly.

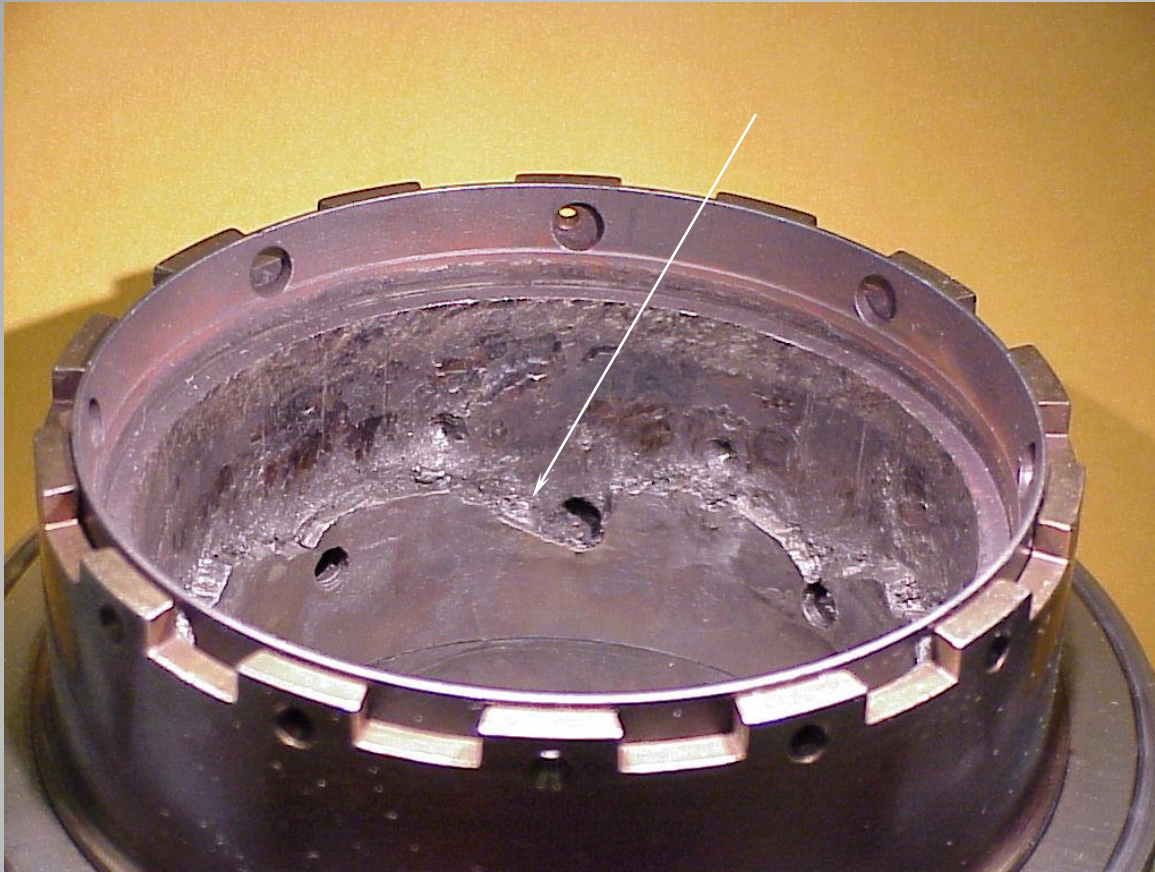
- Fractured Hub (arrow) inside steel sleeve.
- Sleeve is still captured inside its mating splines and bearing assembly.
- No circumferential scoring noted.

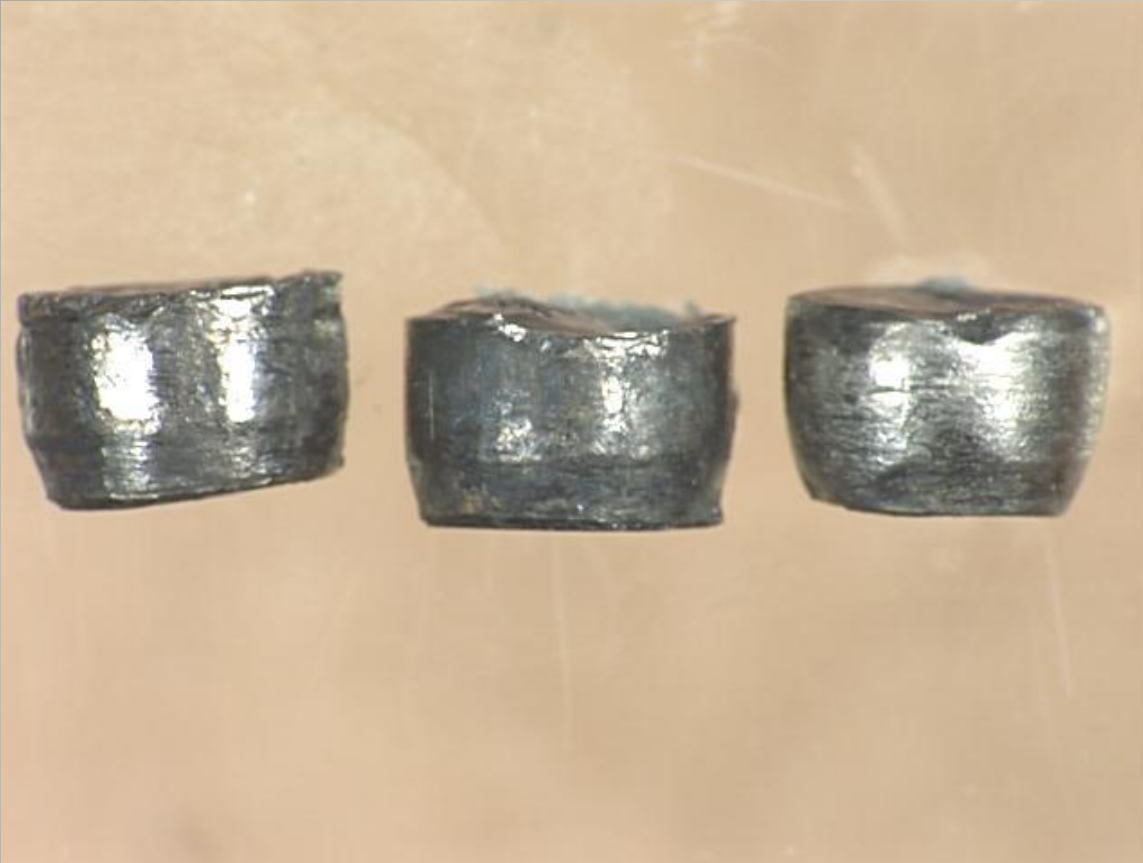
- Three of the group of five pins in relatively good condition.

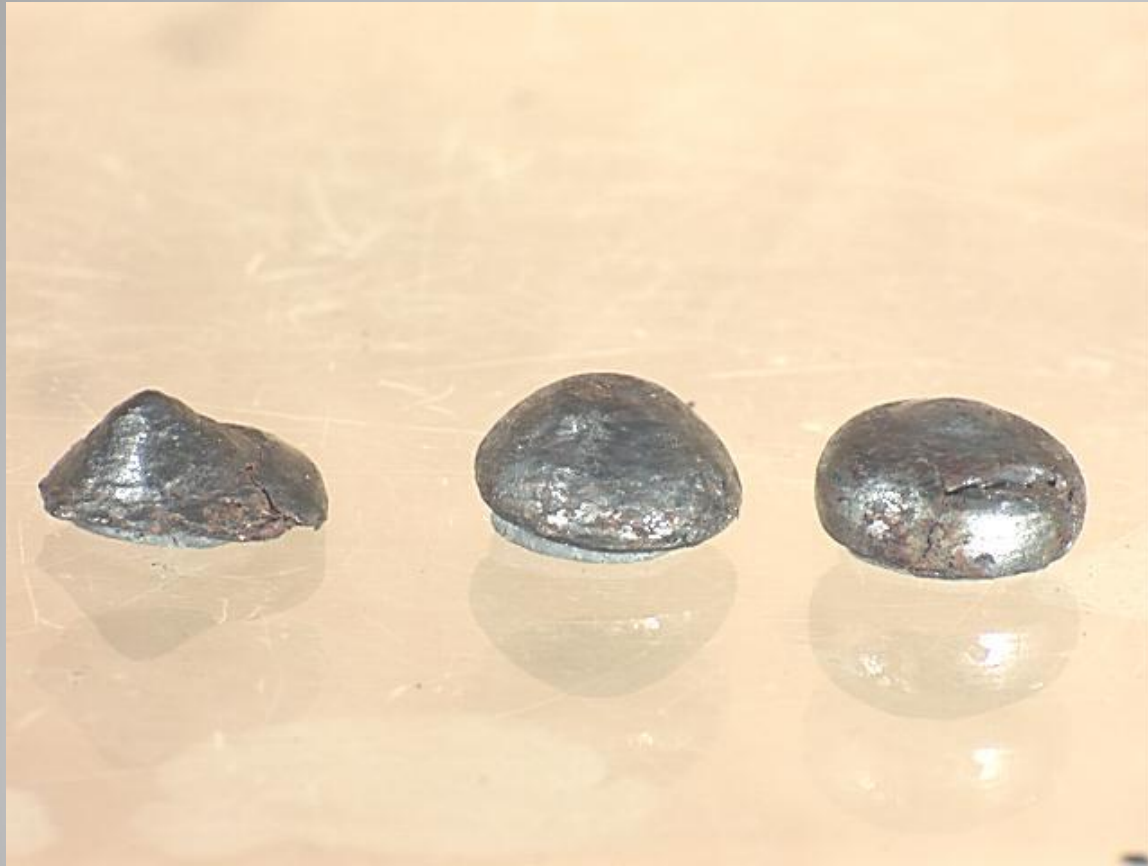
- Three of the five pins were severely deformed.

- Hub found to meet specified compositional and heat treatment requirements.
- The five relatively intact pins met the required compositional and heat treatment requirements.
- The three mushroomed pins were consistent with the required composition, however, precise analysis would have not have produced meaningful results.

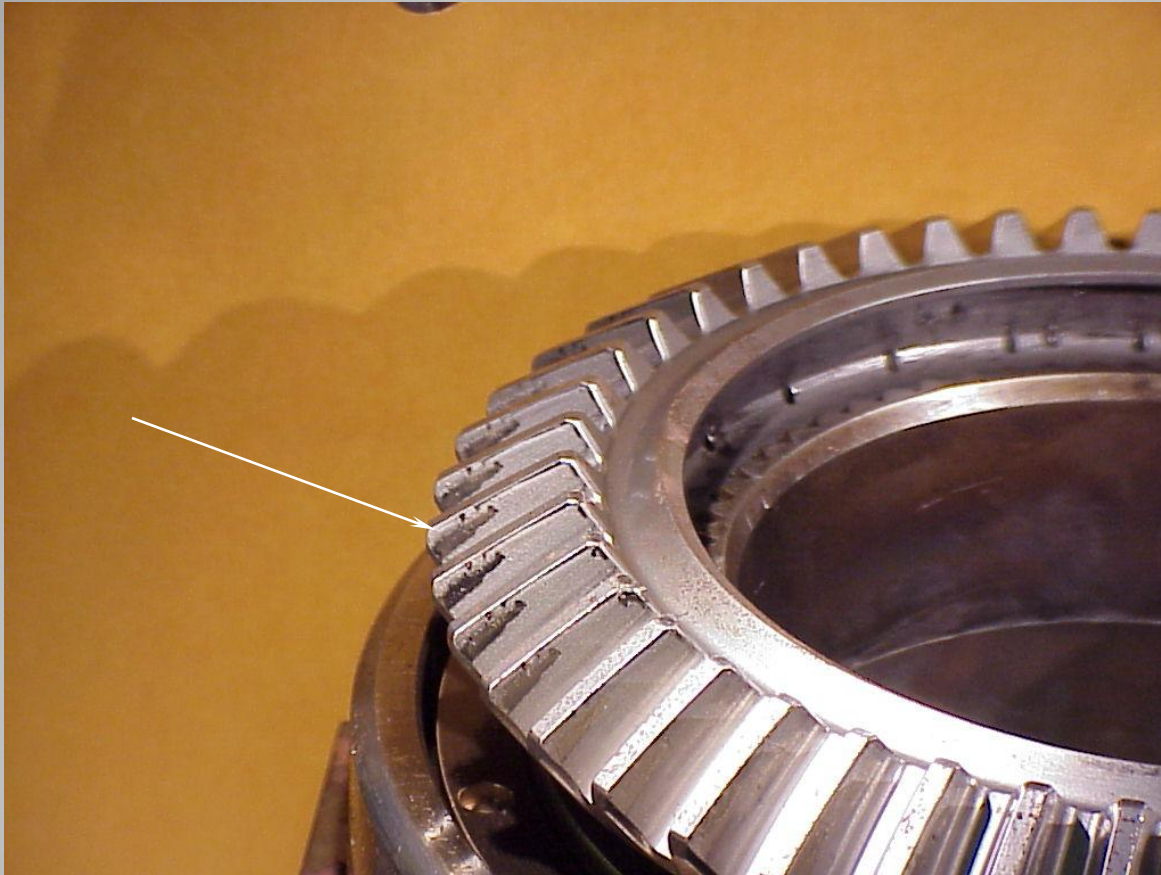
- Gearbox drive bevel gear.
- This unit is connected to and operates at the front of the N2 Hub.
- Teeth never operated in proper contact. Note abnormal wear pattern.

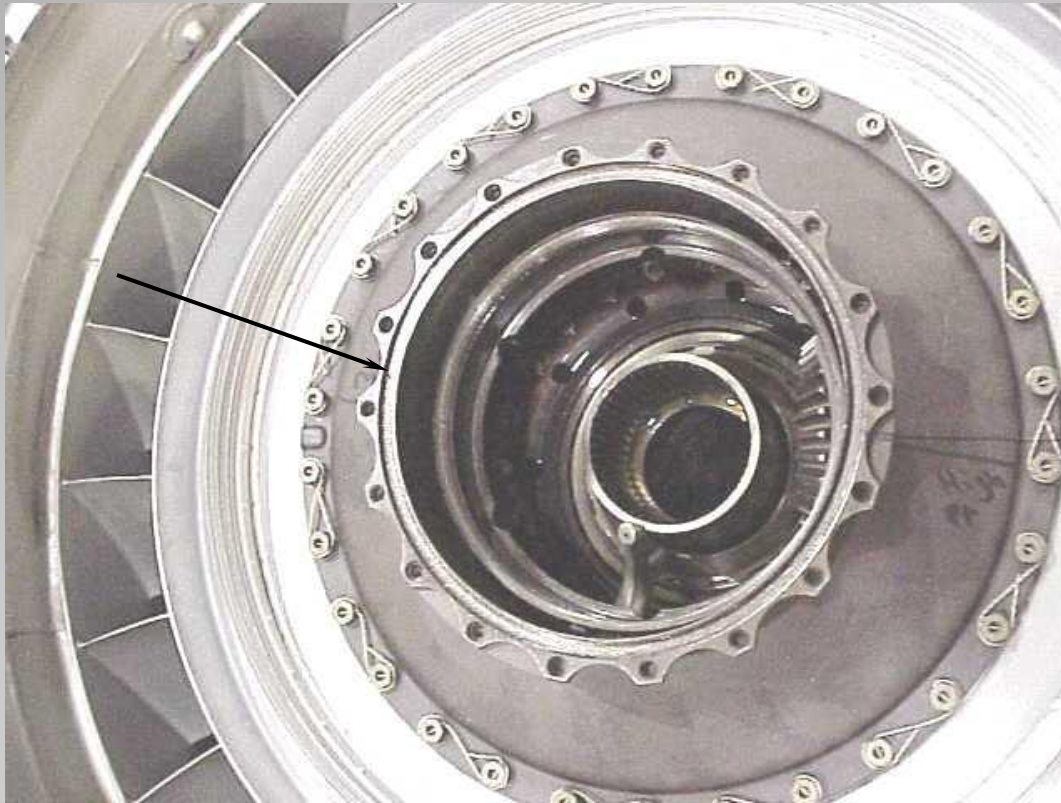
- Observations led to the notion bending stresses had been introduced into the front hub.
- Bearing housing examined.
- Housing found warped.

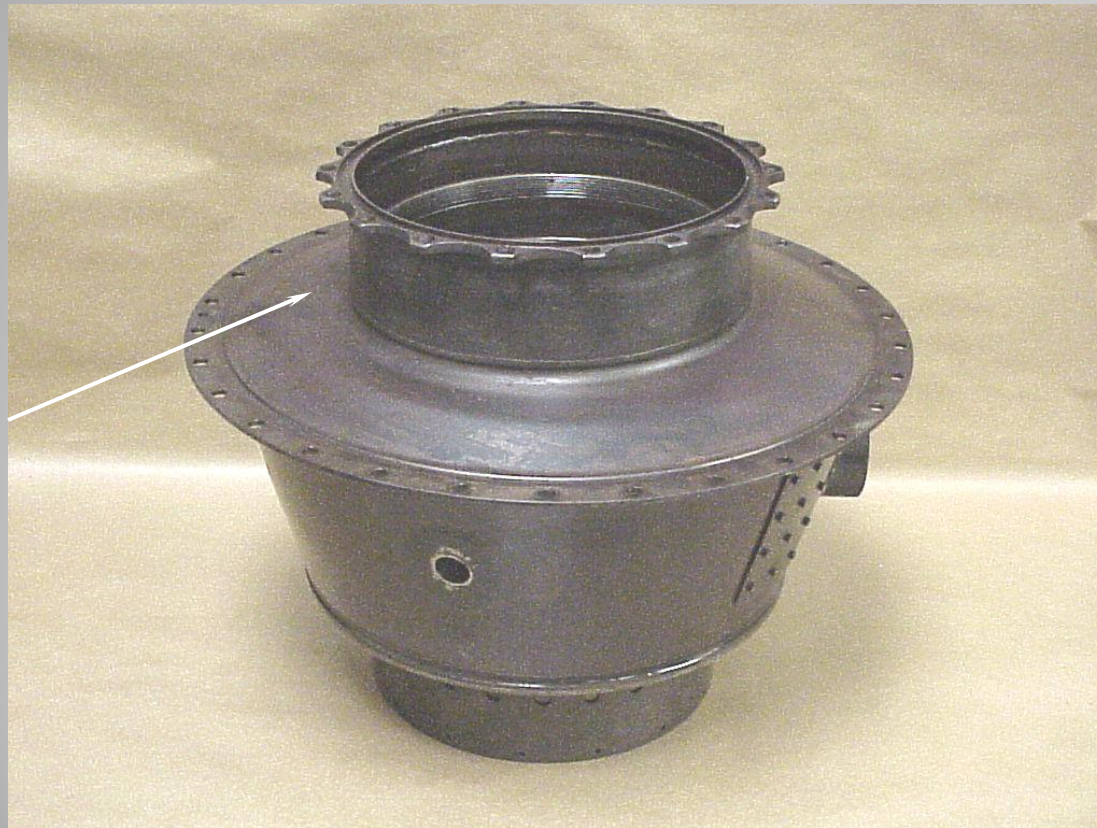
- Bearing housing found warped.
- Reason for warpage unknown.
- Component may have been struck or dropped during engine assembly.

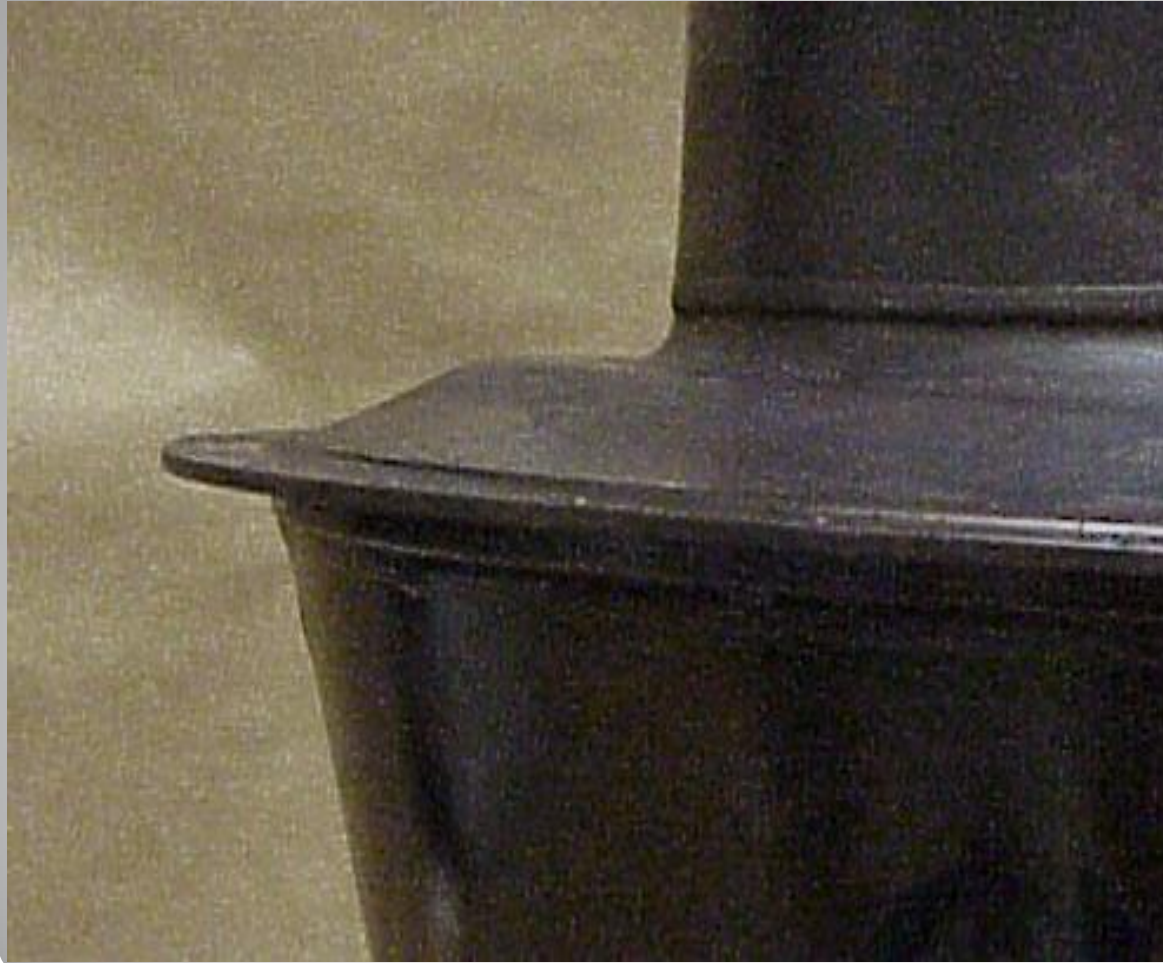
- Warped section of the bearing housing
- Warped housing induced abnormal bending stresses into hub.

- Hub fractured due to fatigue initiated by galling.
- No material chemistry or heat treatment problems encountered.
- Pins appeared to have been machined and fit properly (5 of 8).
- Pins fractured by overload and/or fatigue resulting from abnormal bending moment.
- Mushroomed pins probably last three to fail. Deformed by overload.
- Galling attributed to severe bending moment introduced into the hub end.
- BENDING MOMENT TRACED TO WARPED BEARING HOUSING.
- Origins of bearing housing damage probably due to assembly, handling or transportation.

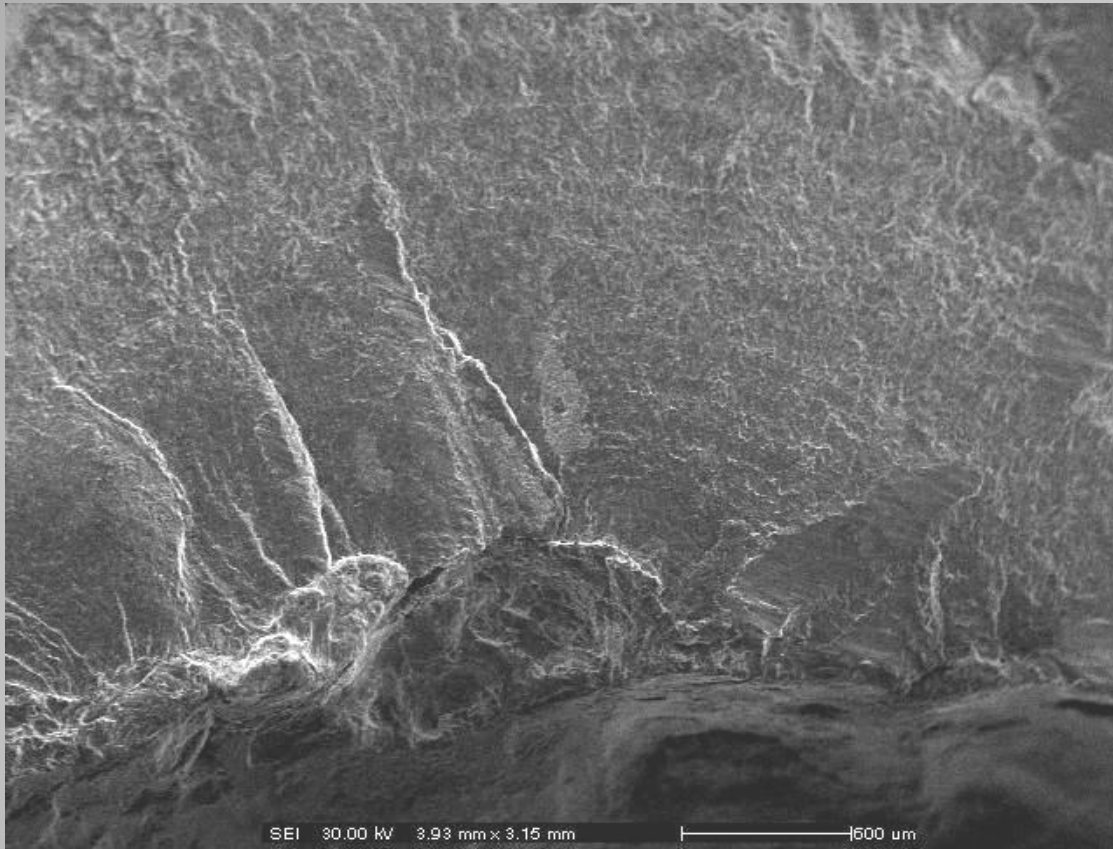
- SEM view of a typical hub crack.
- Bands typical of fatigue.
- Damage at origin caused by galling.

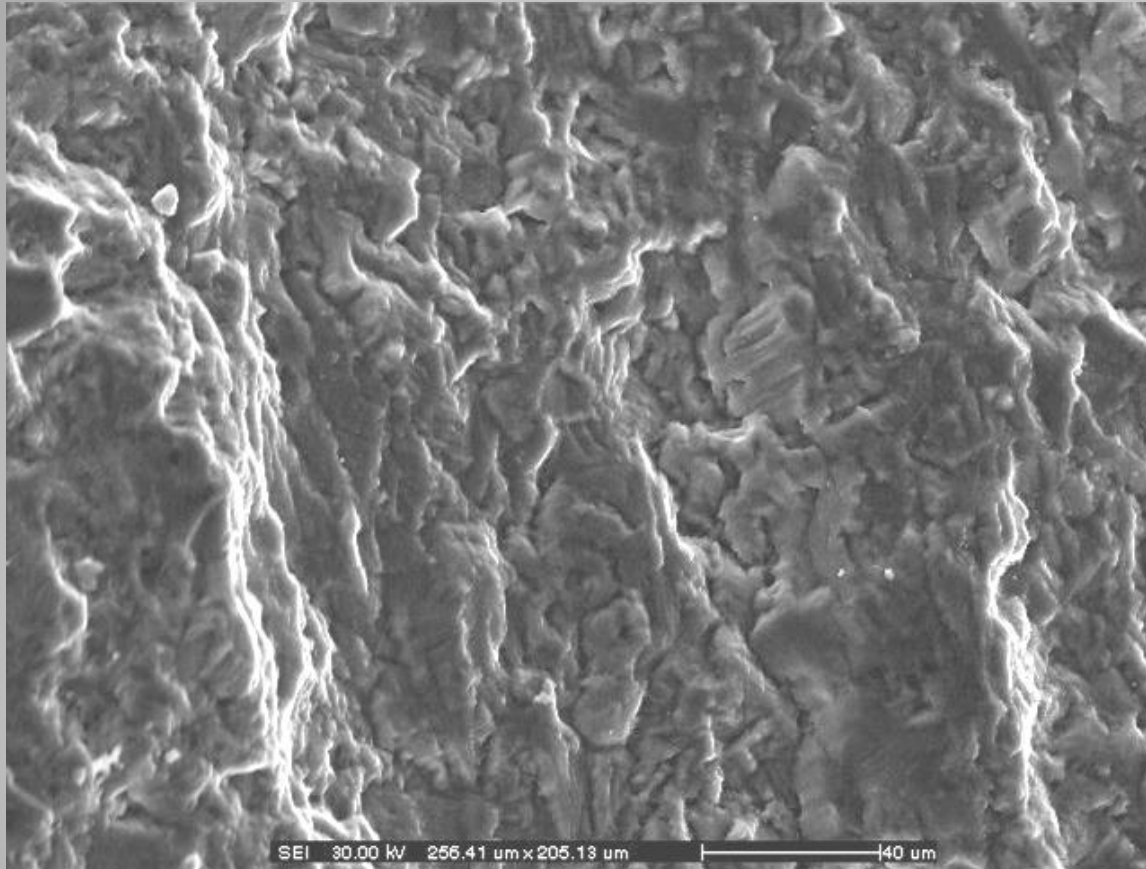
- SEM view of hub fracture surface.
- Features typical of fatigue in Ti alloys.
- Striations notoriously difficult to see.
