Failure Analysis of Turbine Engine In-flight Failure

Luis R. Carney, P.E.
Materials Engineer
Jacksonville, Fl.

AEROMET CONFERENCE

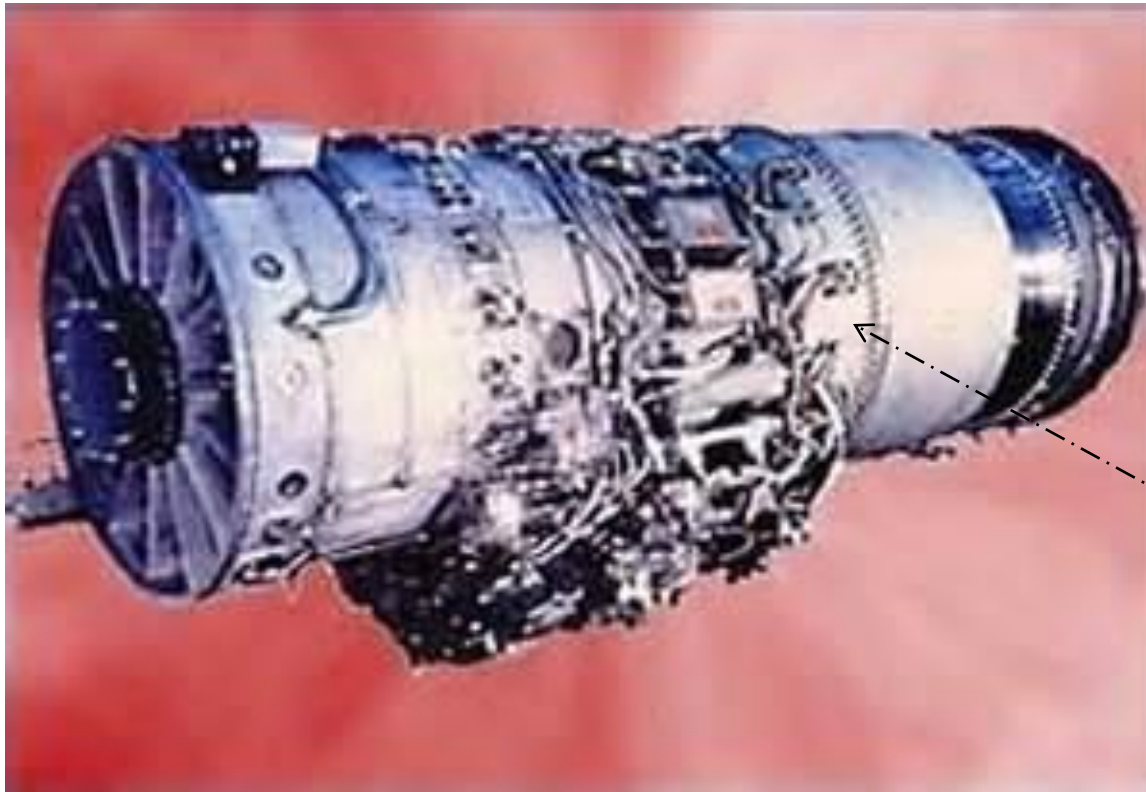
Outward view of Turbine Engine

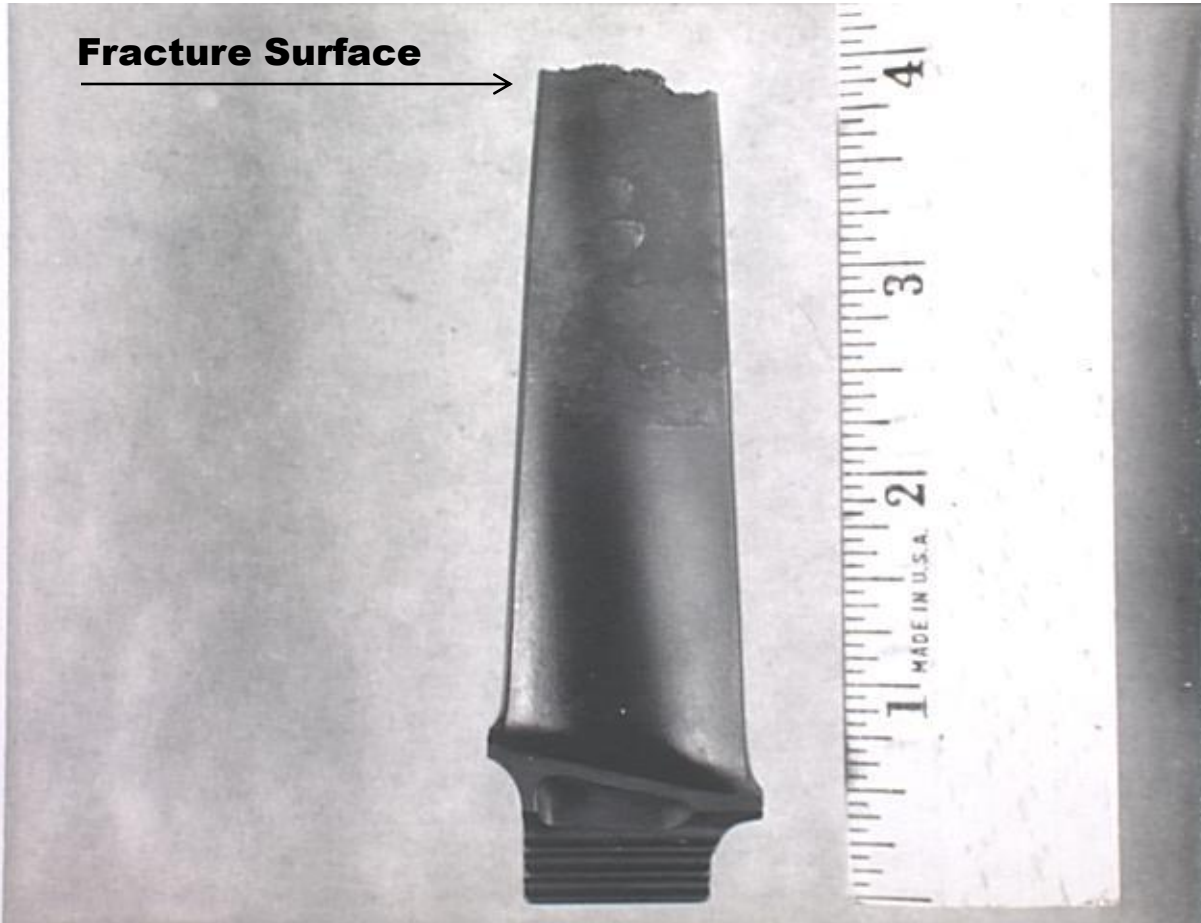
- ▶ Stage 2 turbine blade, as received.

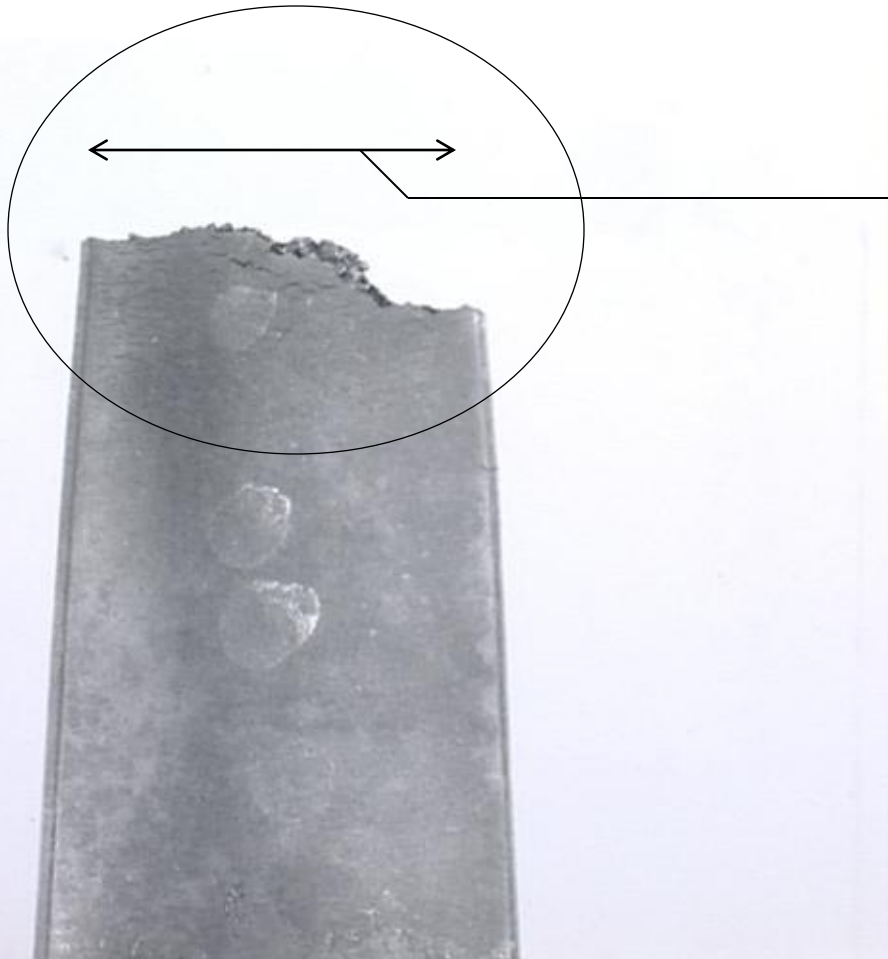
- ▶ Stage 2 fracture.
- ▶ Area surrounding fracture surface exhibited many cracks and slight necking.

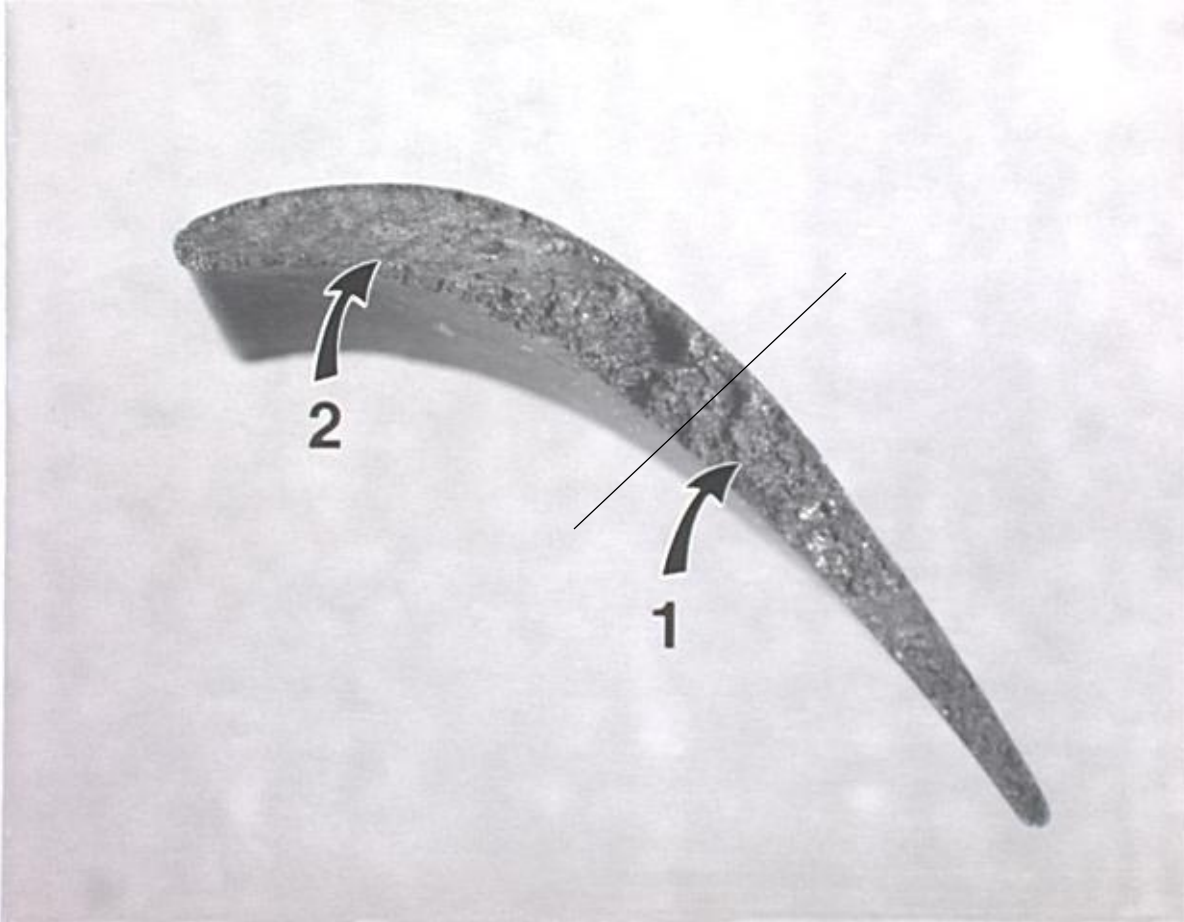
- ▶ Fracture surface of 2nd Stg blade.
- ▶ Area 1 flat & perpendicular to long axis
- ▶ Area 2 at 45 deg to long axis

- ▶ Second Stg. blade initiated failure sequence. Blade chemistry suitable for standard performance engine but not high performance version.
- ▶ Blade failed due to creep/stress rupture.
- ▶ Burner can lugs failed due to fatigue resulting from turbine imbalance and vibrations.
- ▶ Strut overloaded due to turbine imbalance.
- ▶ Damage to other components also consistent with excessive turbine wheel vibrations.
- ▶ Failed blade later found to have been experimental and should have been destroyed. Component entered service through non-traditional supply channels.

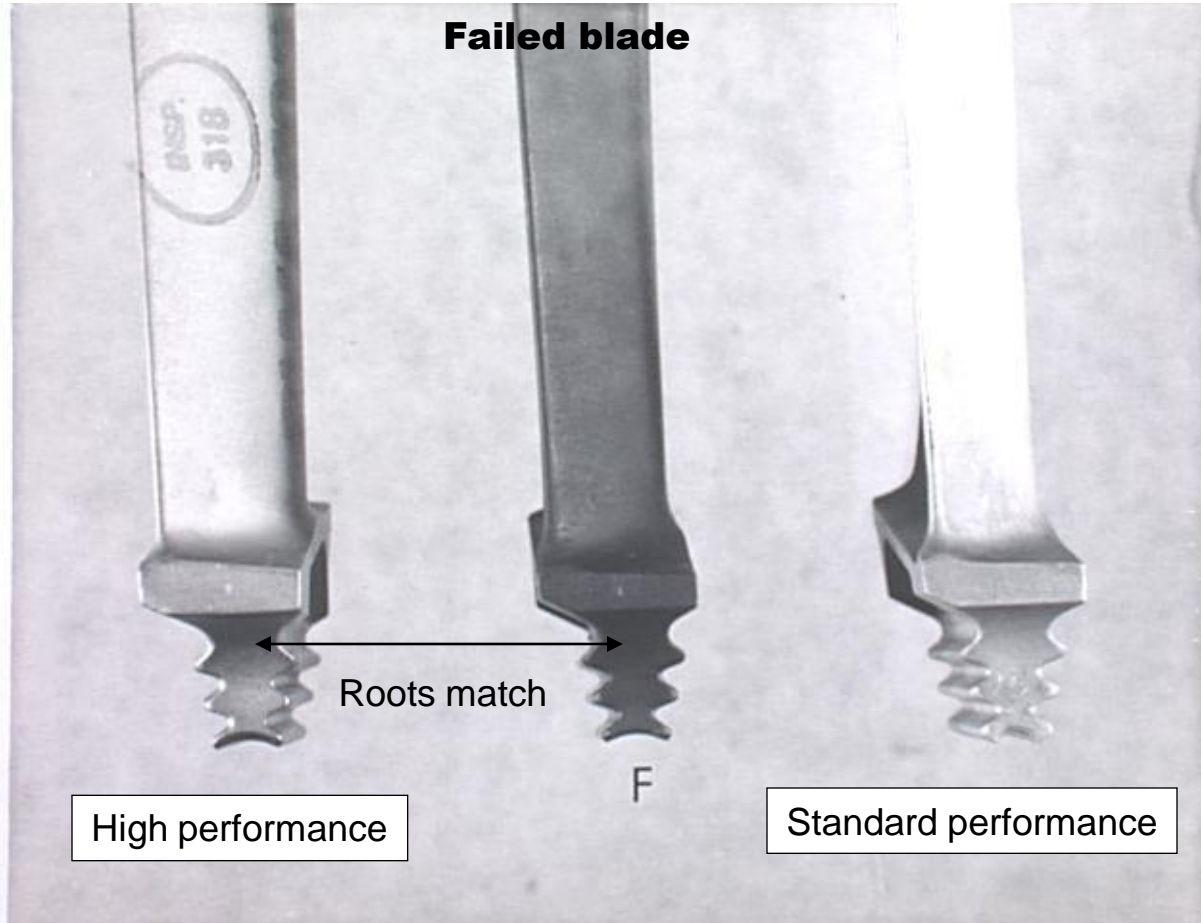
- ▶ Root section (F) appropriate for & fits high performance engine version
- ▶ P/N stamped on (F) inconsistent with high performance requirements
- ▶ P/N (F) matches standard performance (cooler running) engine

- ▶ Second stage blade did not meet compositional requirements. Hardness acceptable.
 - ▶ Second stage blade shape fits high performance engine but has composition of cooler running engine.
 - ▶ Lugs and struts met compositional and heat treat requirements.
-

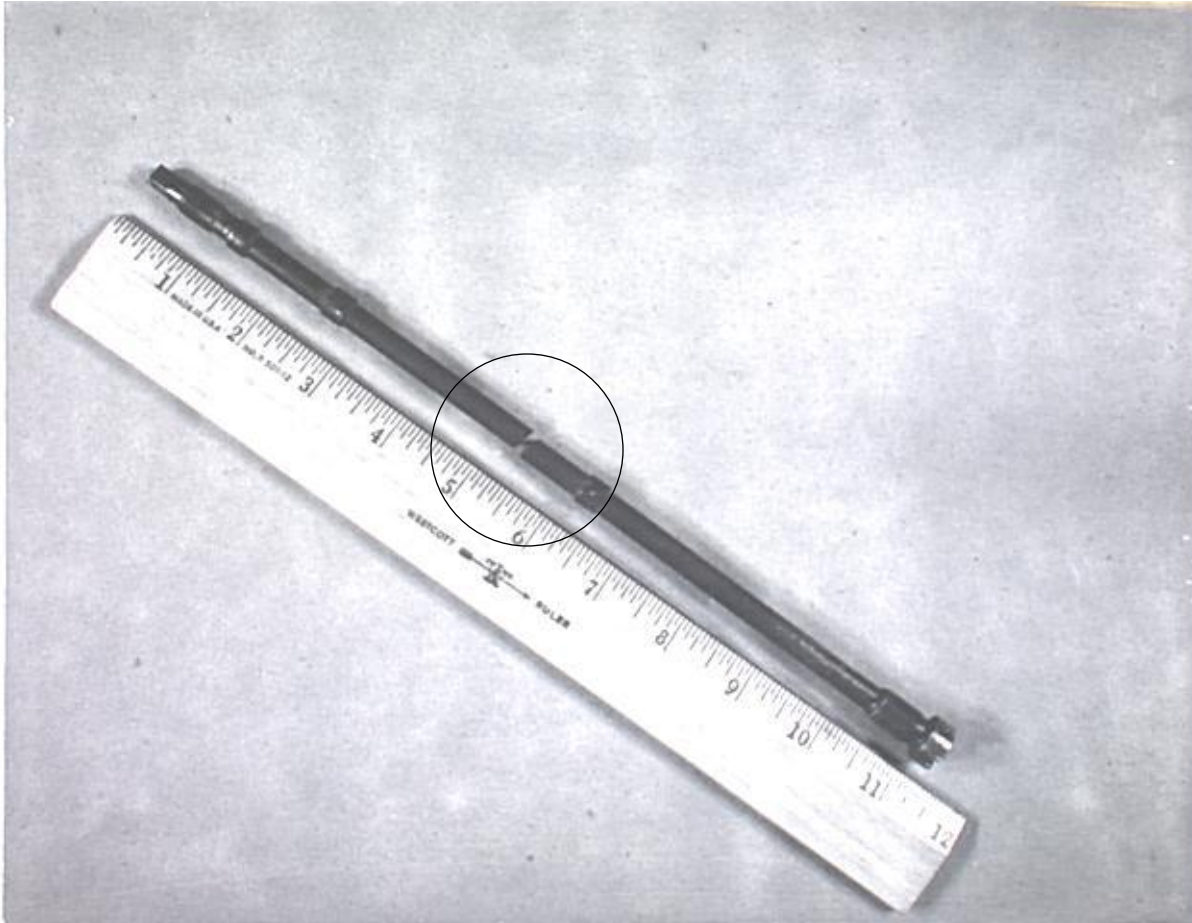
- ▶ #6 bearing strut.
- ▶ Fracture zone circled.

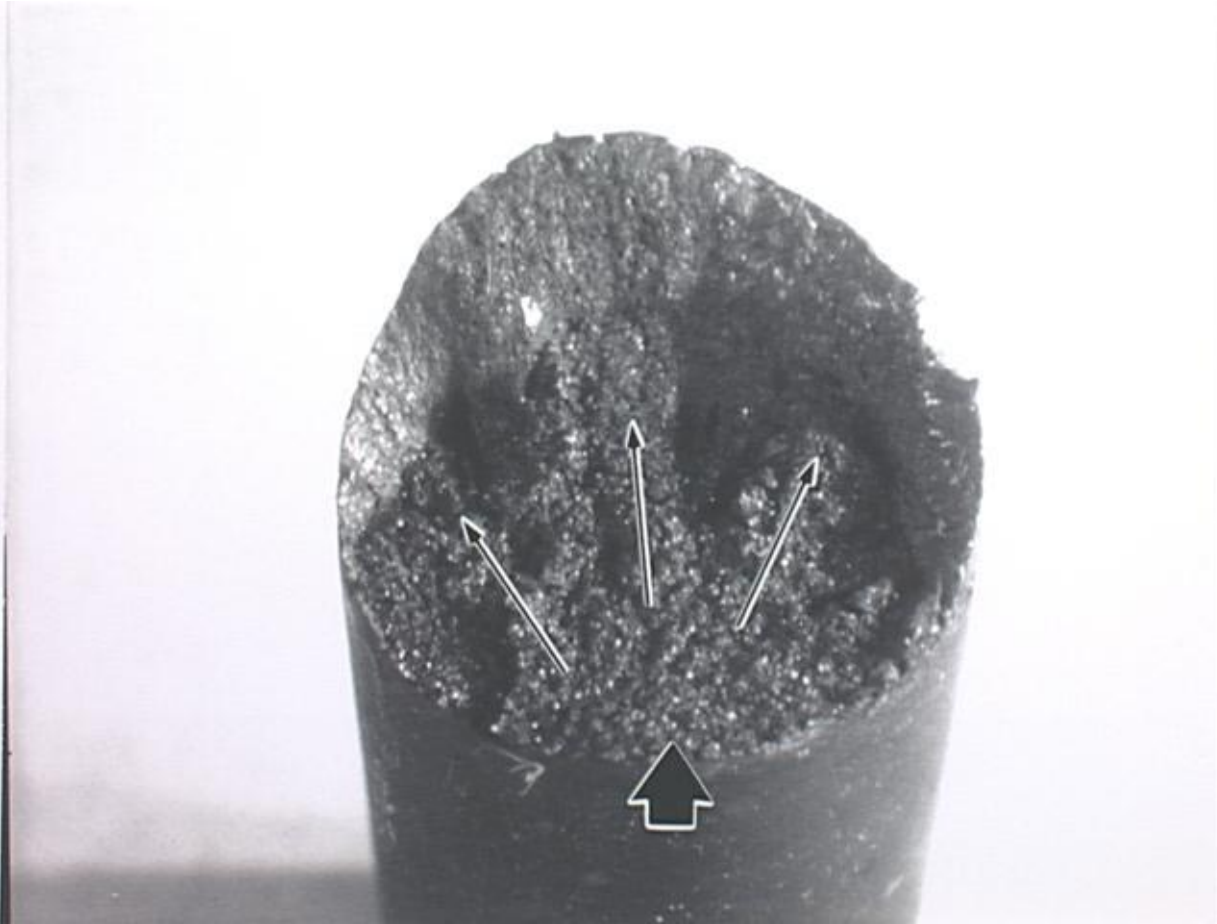
- ▶ Fracture surface of #6 bearing strut.
- ▶ Fracture initiation region and propagation direction noted

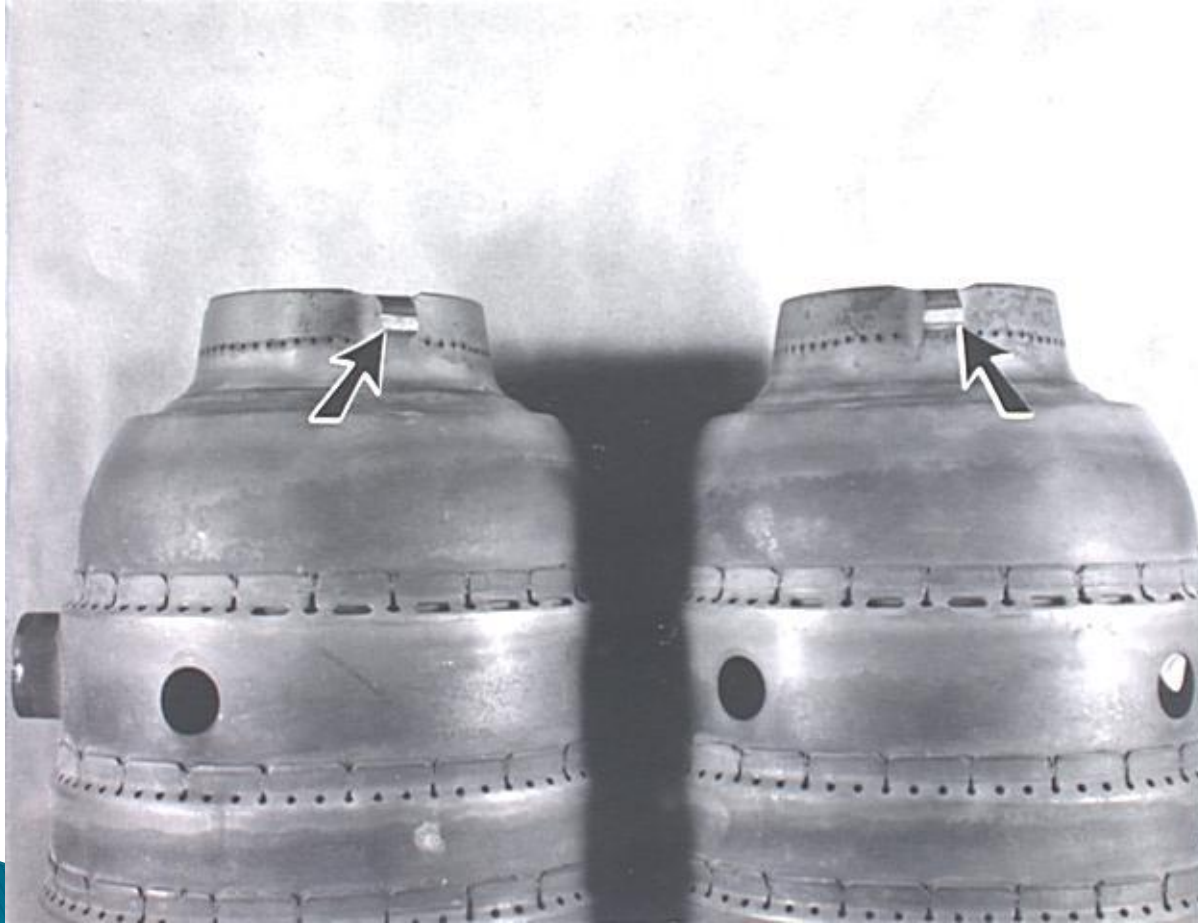
- ▶ Fractured burner can lugs, as received.

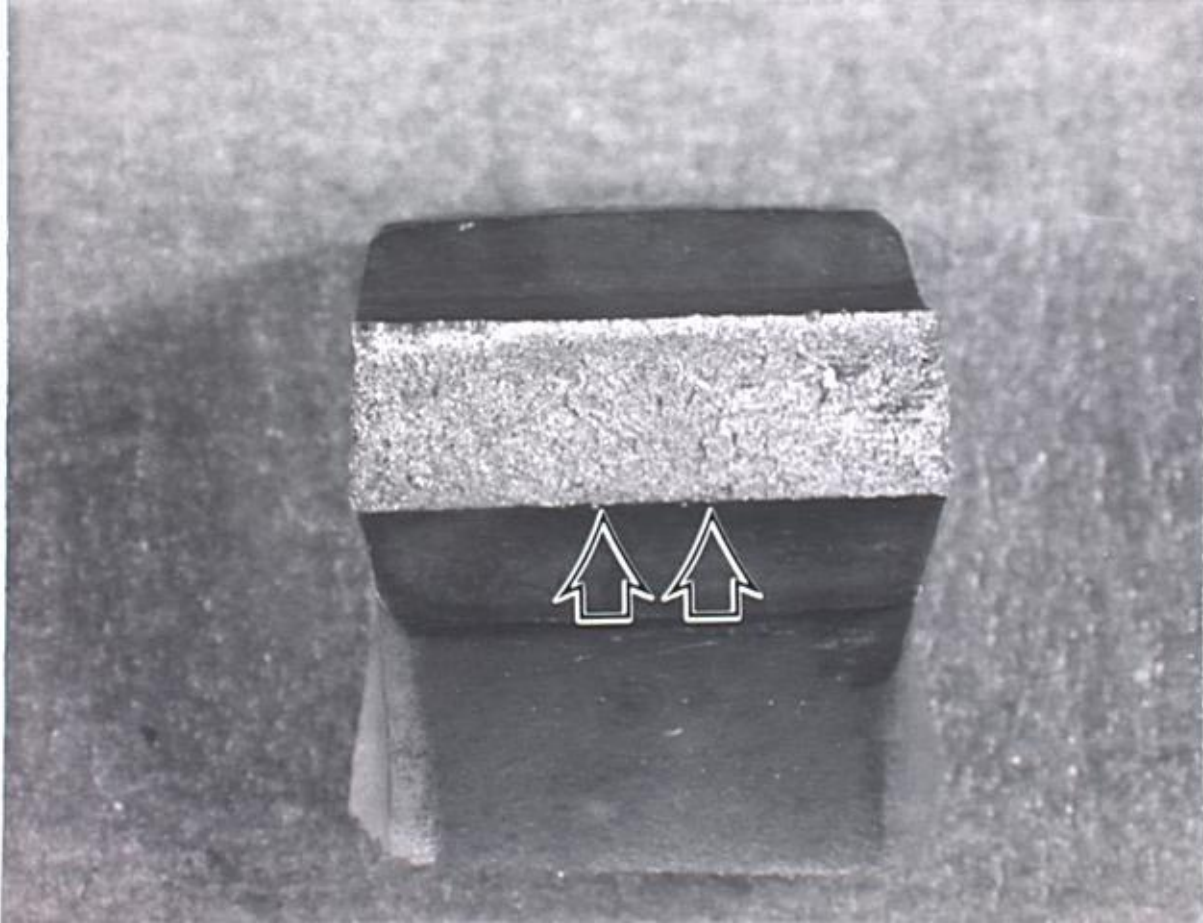
- ▶ Burner can lug fracture surface.
- ▶ Initiation region noted
- ▶ Bands typical of progressive fracture observed.

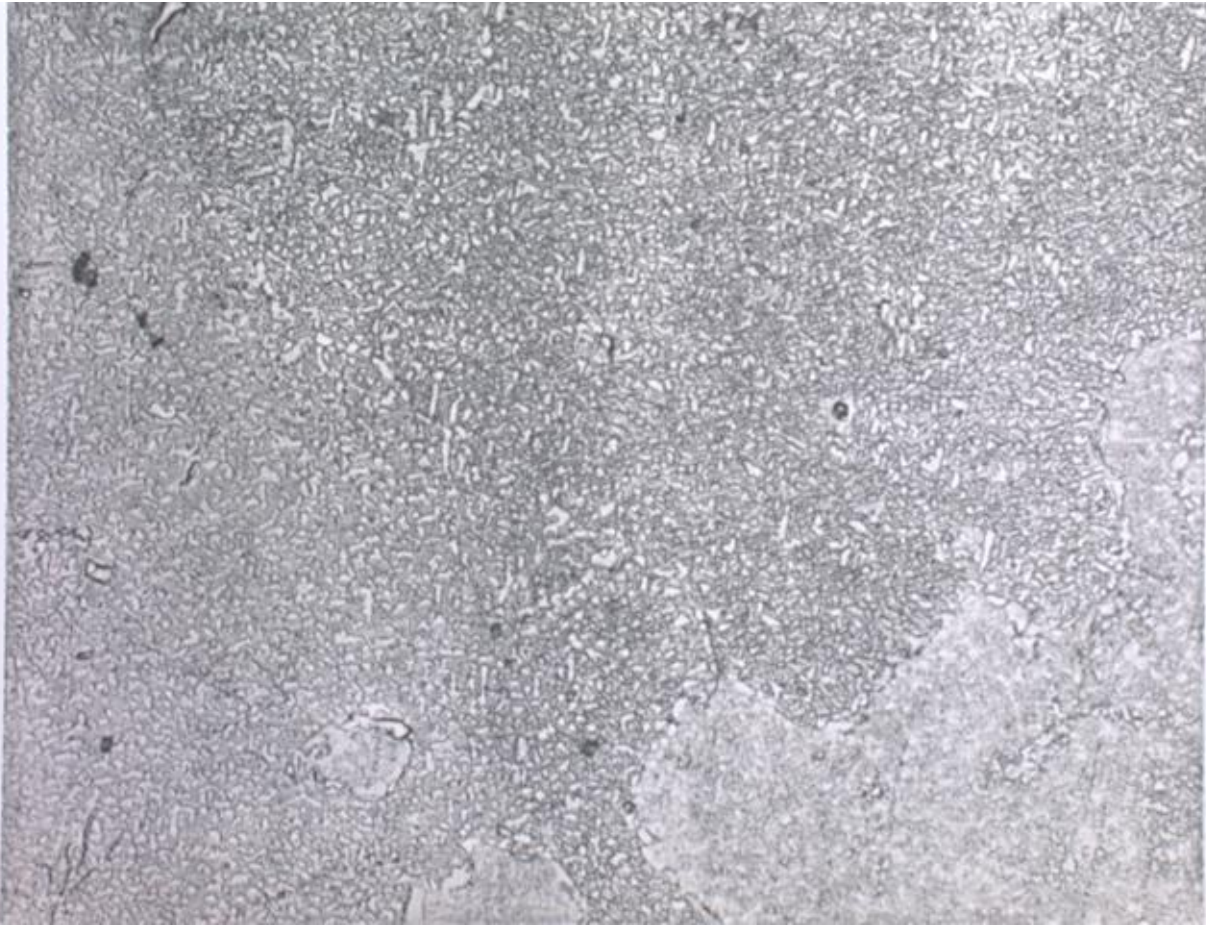
- ▶ Metallographic inspection of 1st stg blade used to determine if engine overtemped.
- ▶ No microstructural degradation was noted.
- ▶ Engine not overtemped

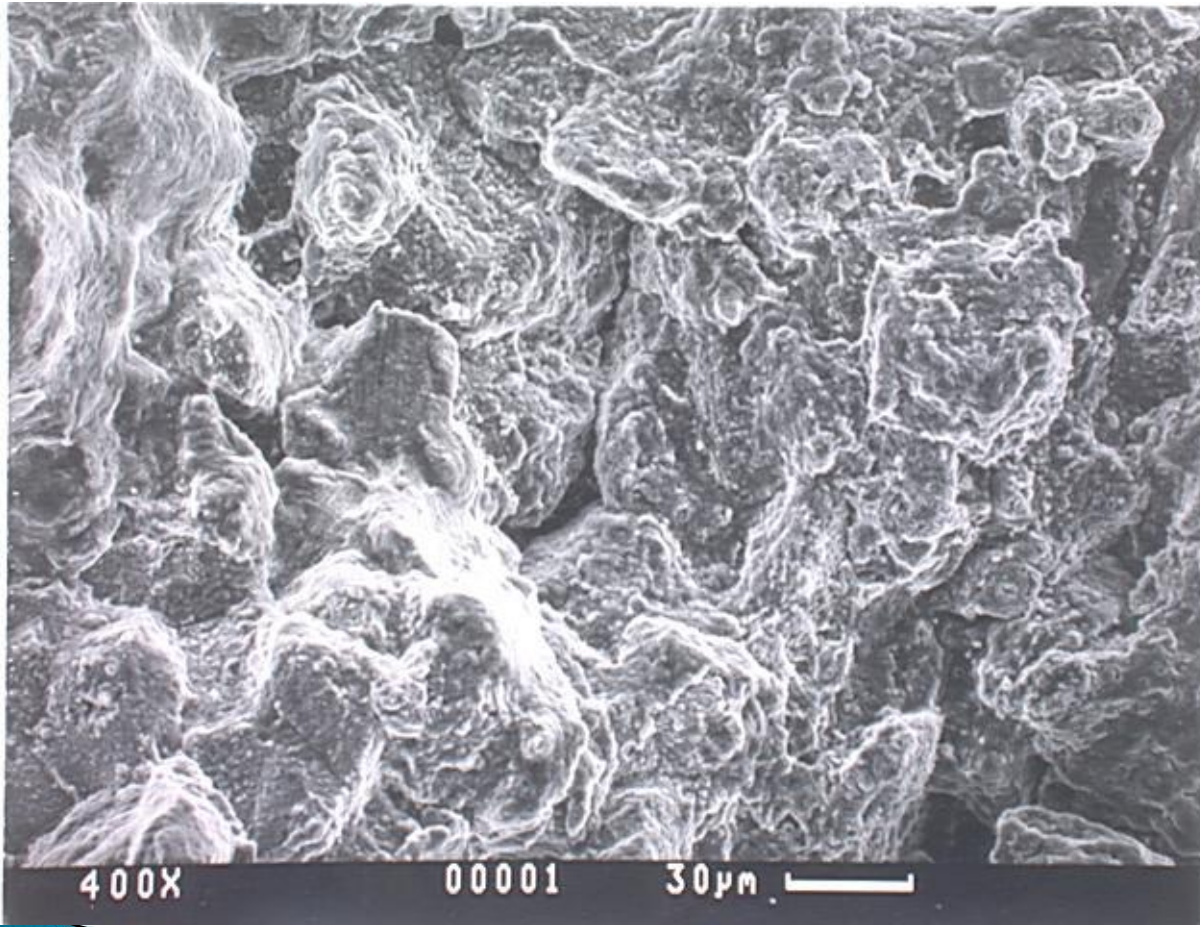
- ▶ Scanning Electron Microscope view of Stg 2 blade in area #1.
- ▶ Intergranular fracture features noted—creep suspected.
- ▶ Surface somewhat oxidized due to normal high temp exposure.

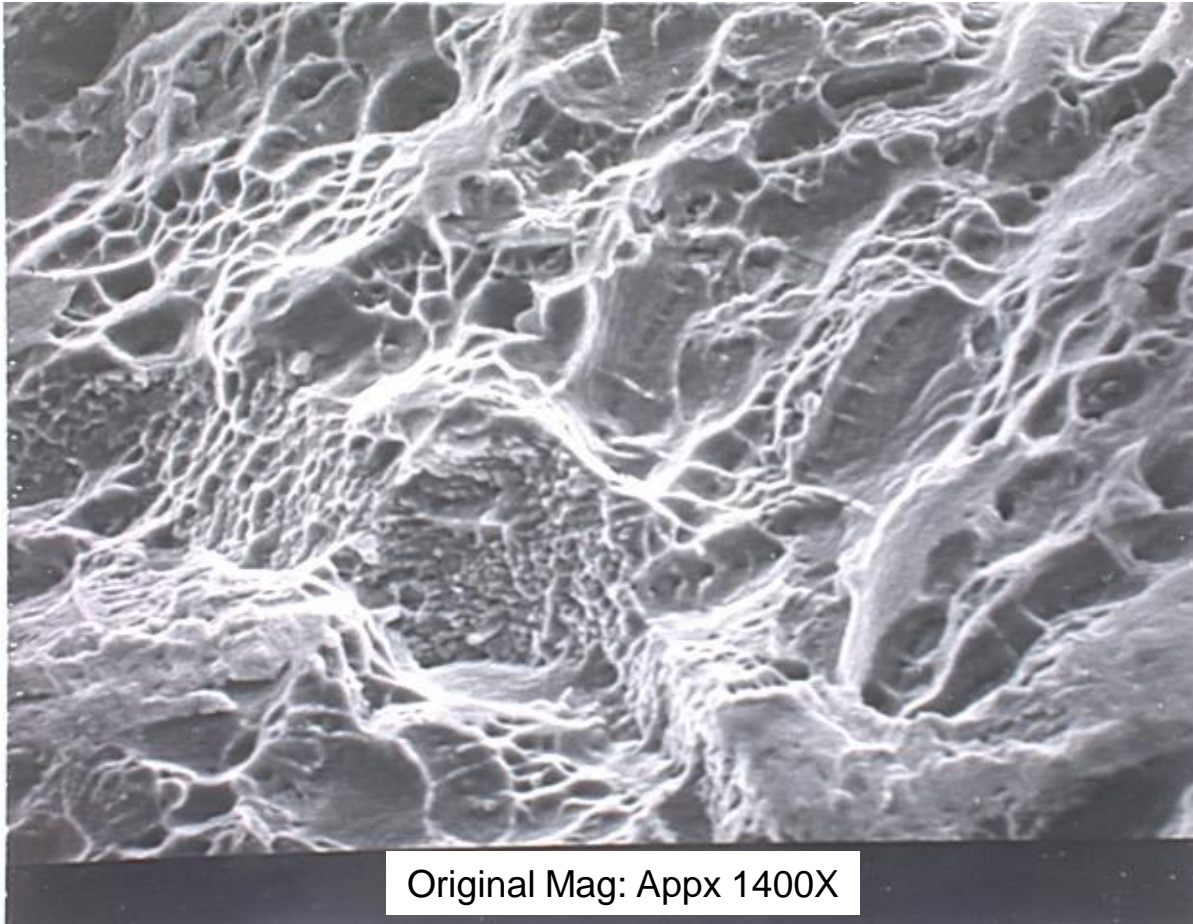
- ▶ SEM view of Stg 2 blade in area #2.
- ▶ Microvoid coalescence noted—typical of terminal stage overload.
- ▶ Surface relatively clean and free of oxidation.

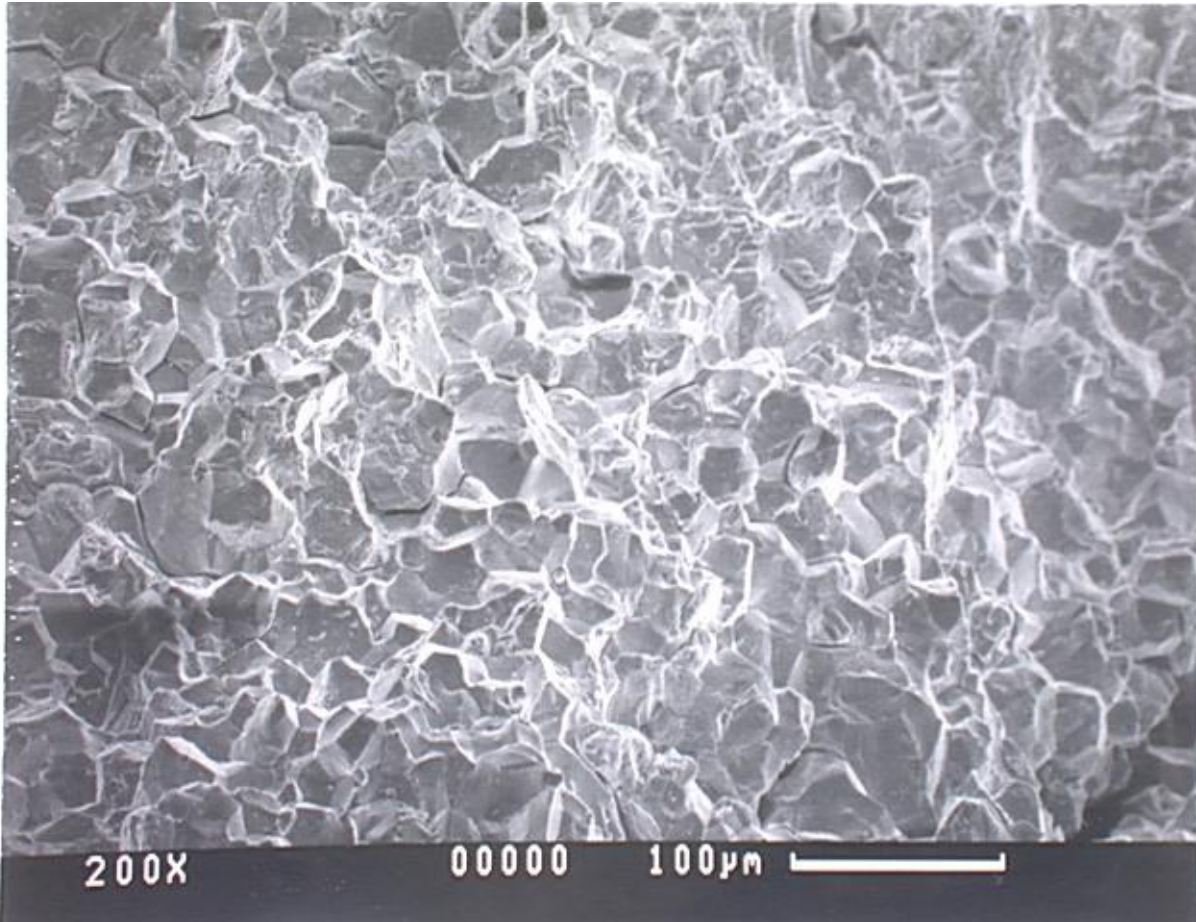
- ▶ Fracture surface of support strut.
- ▶ Clean intergranular fracture noted.
- ▶ Features found to be typical of overload in Waspalloy.

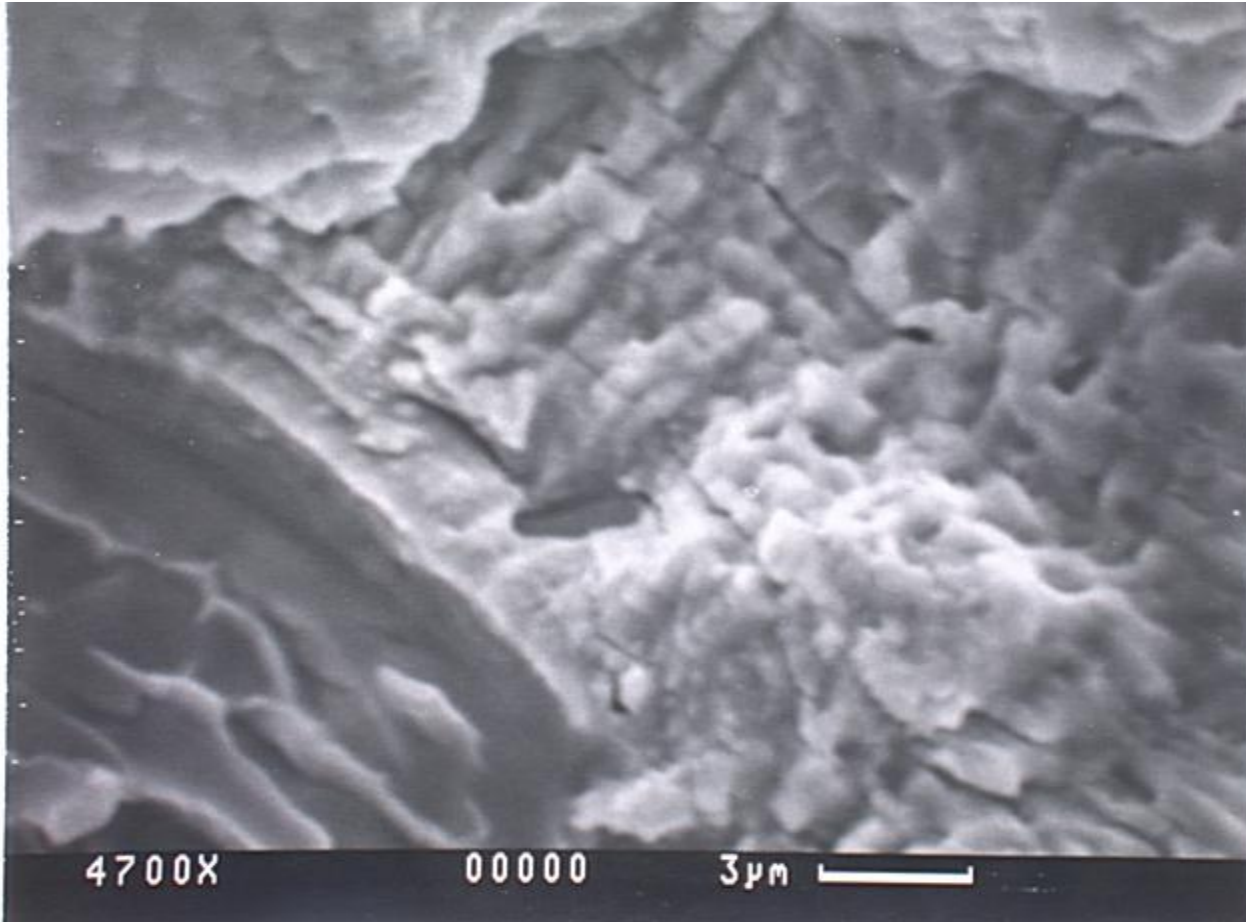
- ▶ Image typical of burner can lugs.
- ▶ Striations typical of fatigue.
- ▶ Fatigue suggests engine vibrations above normal.
