Tailhook Failure

Presented to University of Florida Engineering Students

Luis R. Carney Ph.D, P.E.
Jacksonville, Fl.

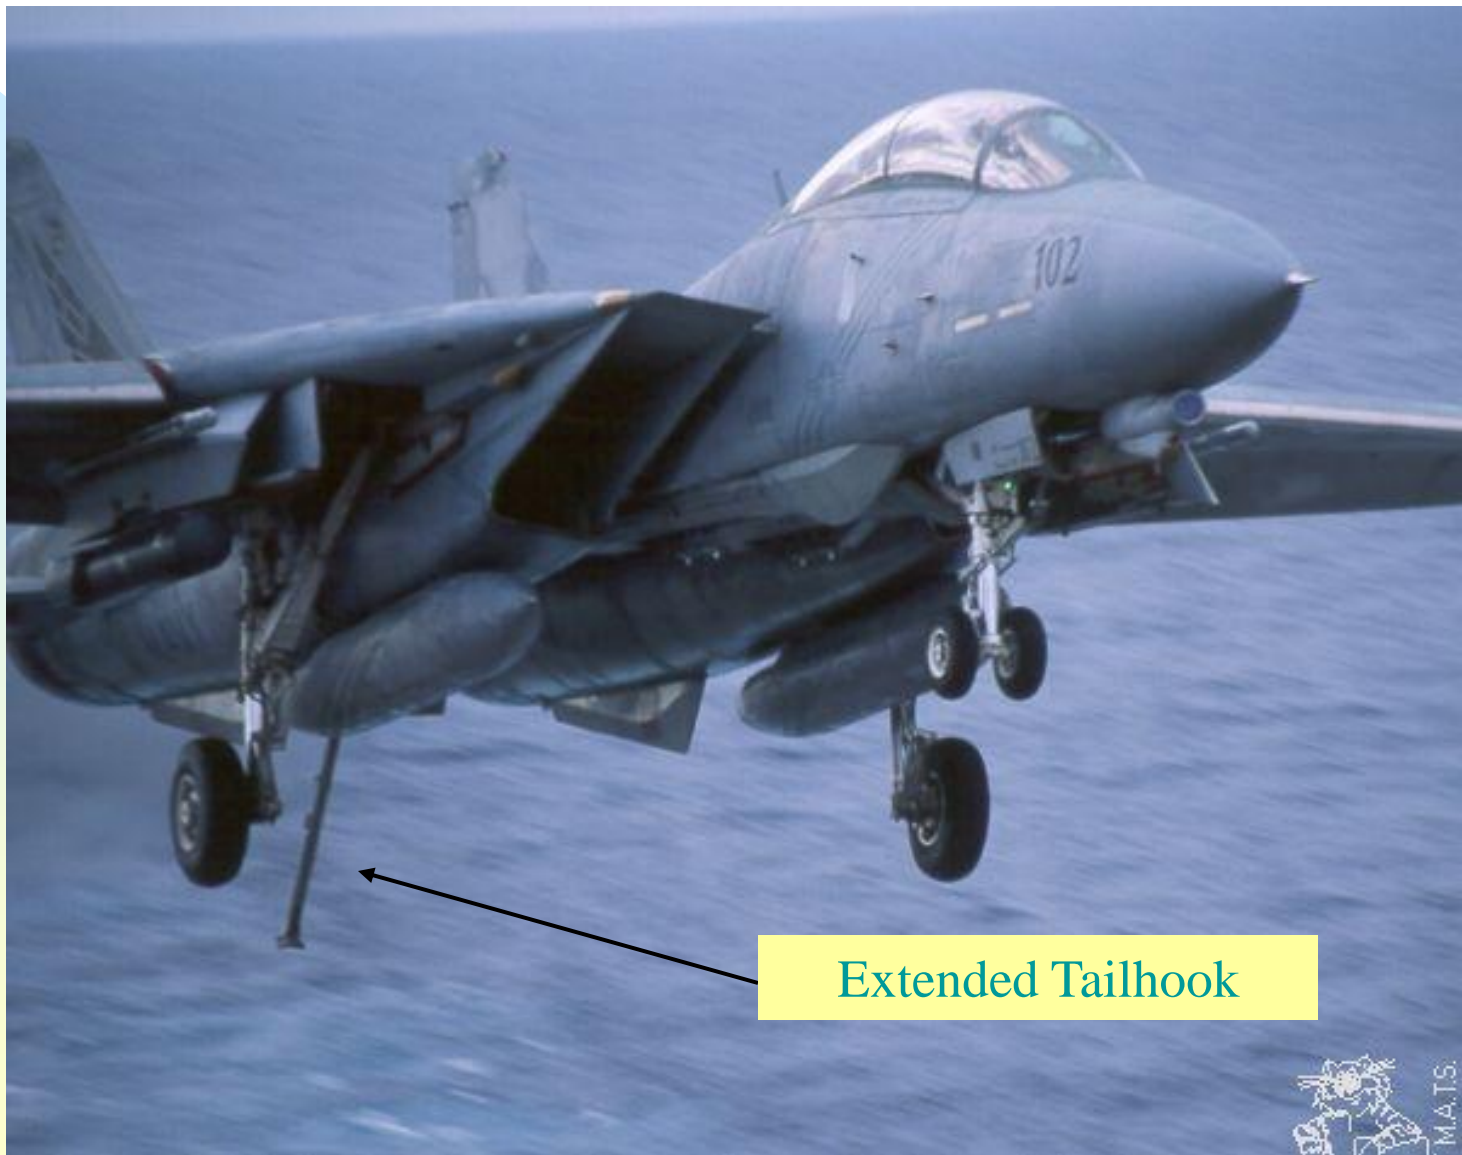
Extended Tailhook

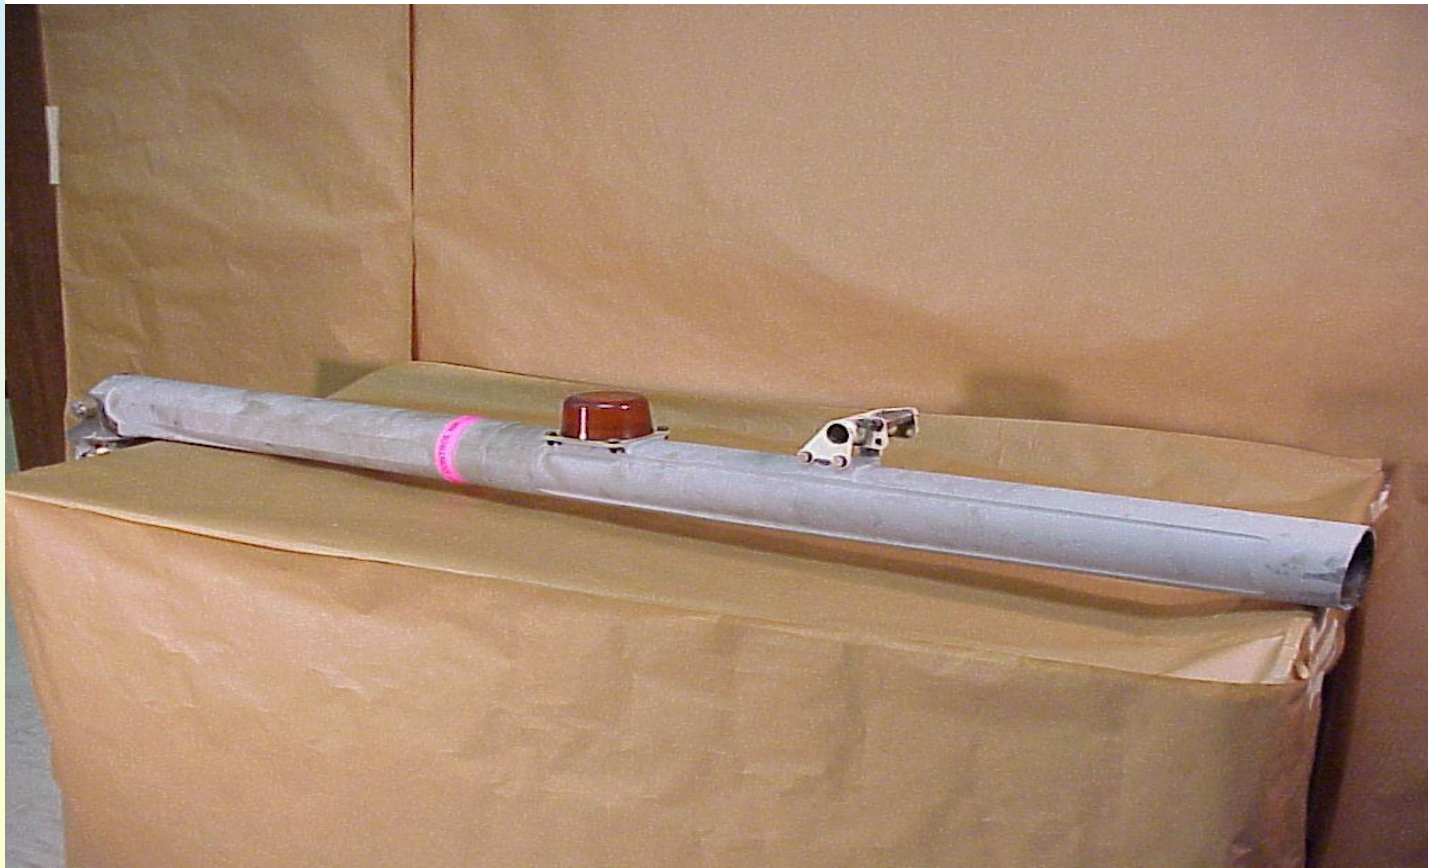
Tailhook section, as received.

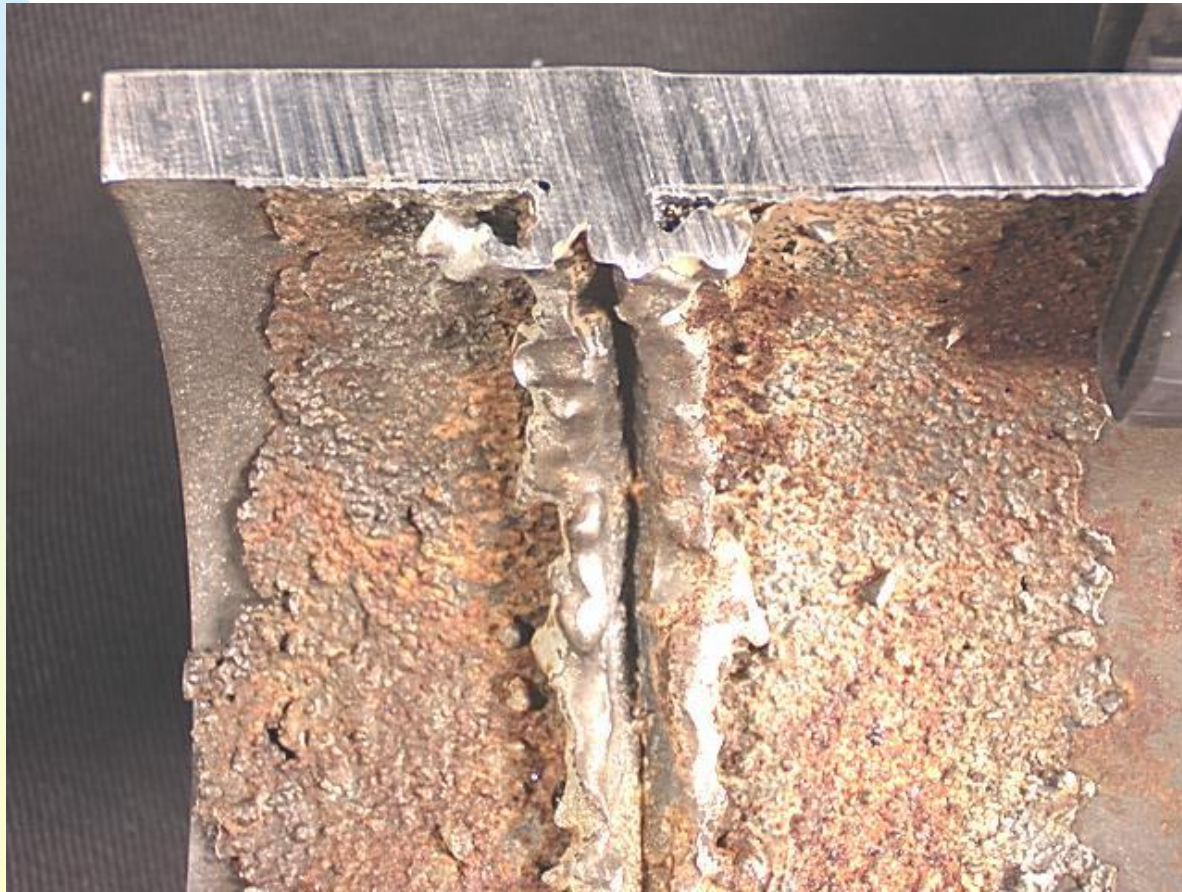
Inside of Tailhook Surface. Normal welded joint & flashing.

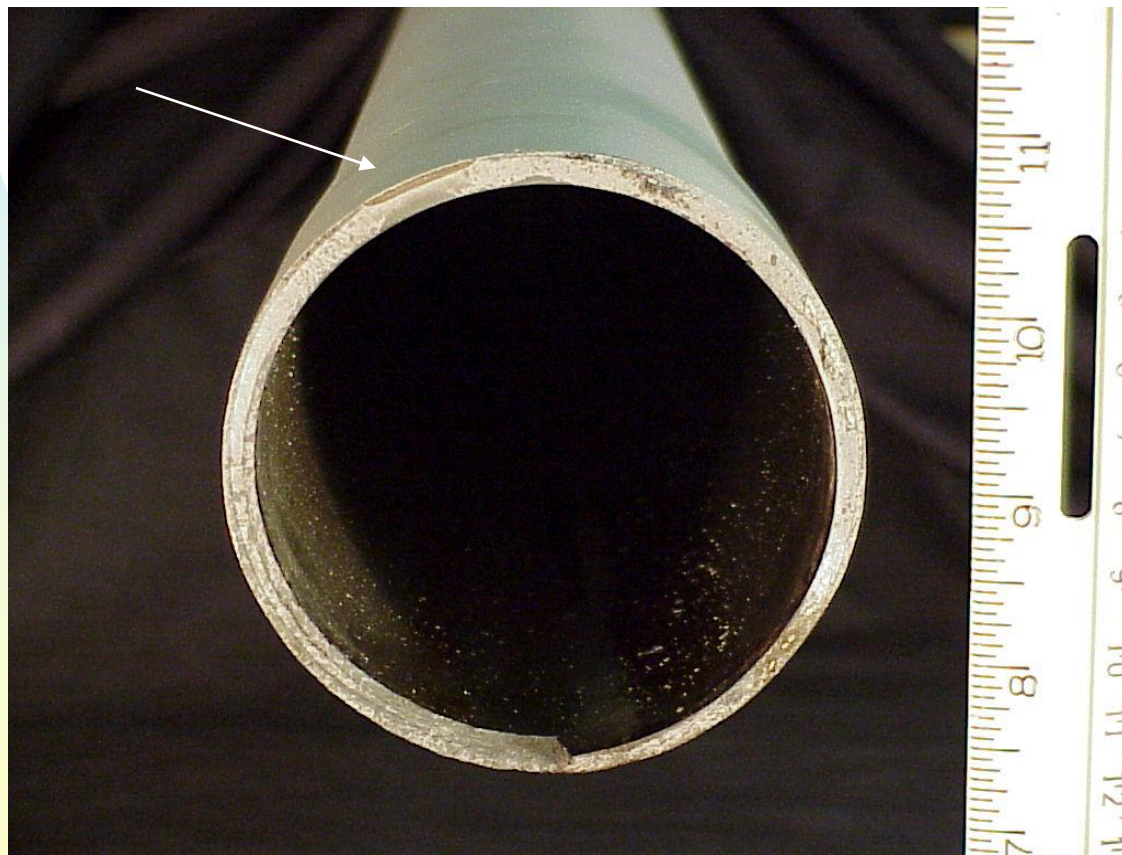
Fracture surface. Defect on O.D. noted

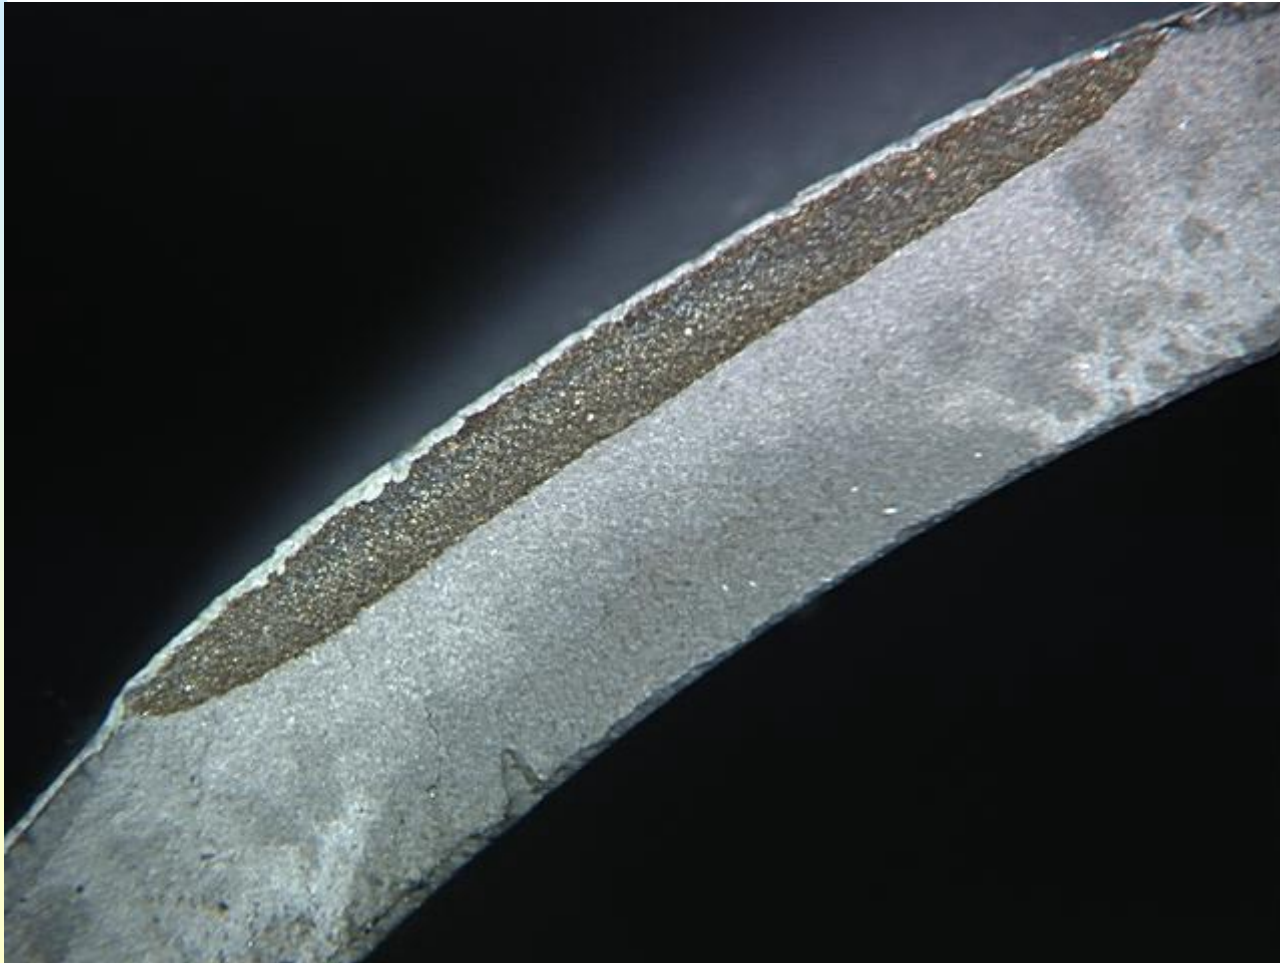
Crescent shaped fracture initiation site (dark). Overload beyond that region.

- Suspected hydrogen generated during Al stripping process.
- Suspected residual stresses from unintentional impact helped to absorb hydrogen into area.
- Tested this theory in the laboratory. Proven plausible
- Used samples of AISI4340 in reverse bending to simulate component loading—they failed early.

- Fracture attributed to hydrogen embrittlement during rework.
- Sodium hydroxide stripping of aluminum coating determined in the laboratory to produce sufficient hydrogen to initiate fracture.

- Cryogenic testing instituted to find small cracks.
- New rework NDI procedures in place.
- NDI procedures developed for operating squadrons.
- All assets inspected.
- Baking for HE relief 375F/24 hr instituted.
- Monitoring continues.
- No additional failures in 8+ years

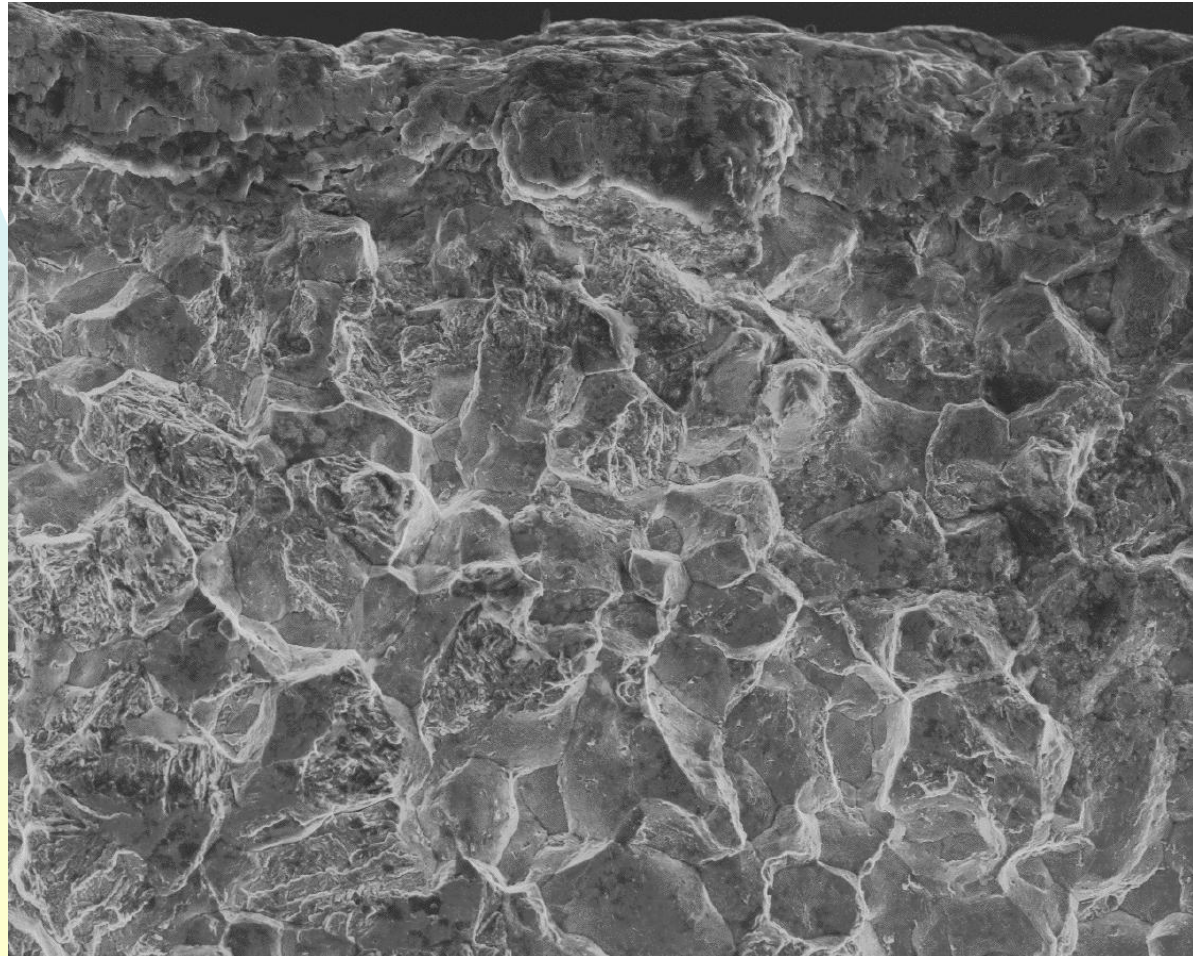
**Fracture surface under SEM:
Features show a blend of intergranular and
transgranular fracture path**

- Fracture origin intergranular/transgranular.
- Surface characteristic of environment assisted cracking:
- Possibilities: Stress corrosion cracking (SCC), hydrogen embrittlement, liquid metal embrittlement, others ...
- SCC seemed most plausible until history was examined.
