Failure Analysis of Turbine Engine Compressor Front Hub/Disk

**Luis R. Carney, P.E.
Materials Engineer
Jacksonville, Fl.**

AEROMET CONFERENCE

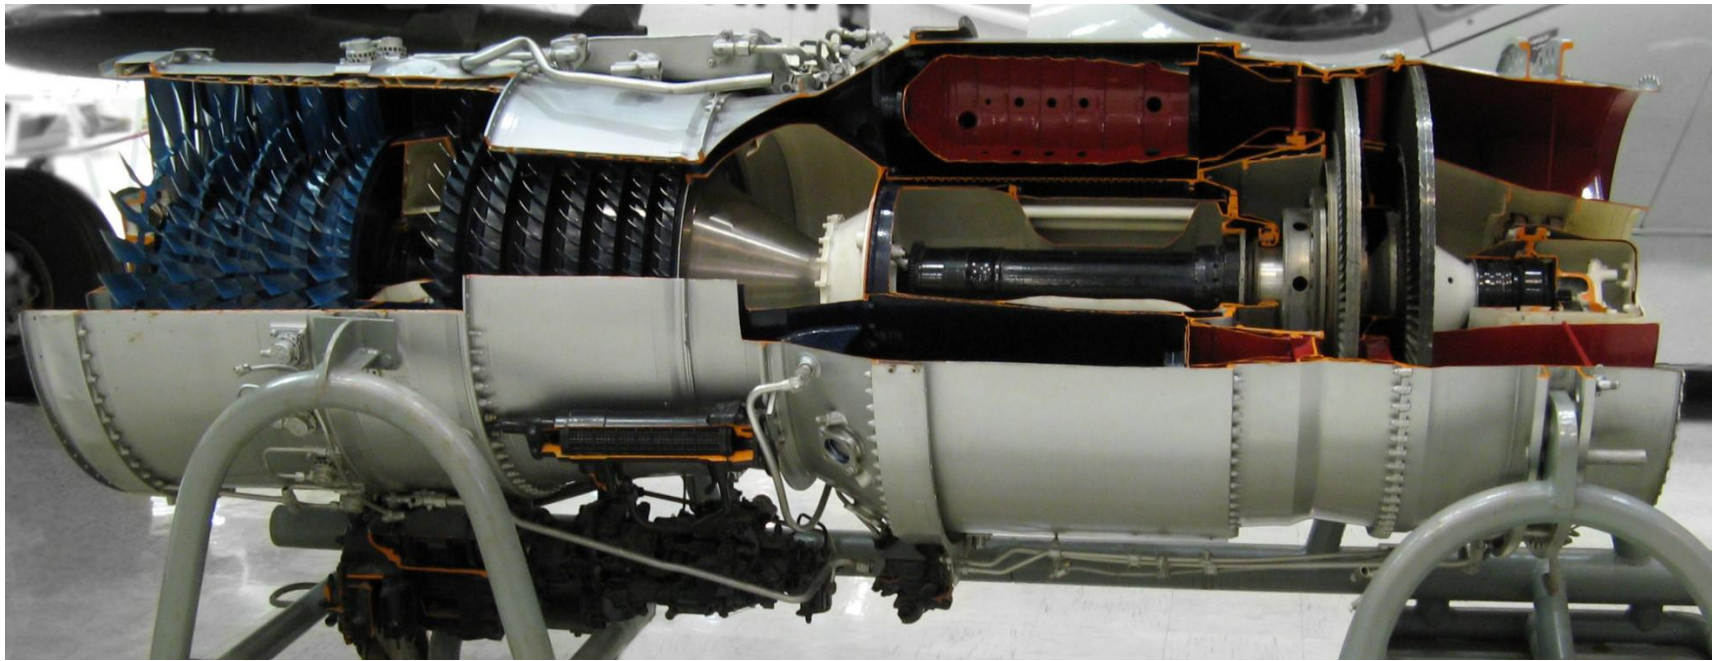
Engine Cross section

- Engine being test run after overhaul
- Time Since Overhaul: 0 hours
- Time on Hub: Apx 1,893 hours.
- Test run revealed high breather pressure & oil out of bleed valves
- Disassembly revealed fractured N2 hub
